JSW Energy Limited

Sub: Ash Notification S.O. 5481(E), 31st December 2021 Statutory Compliance Report of 2 x 130MW & 2 x 300 MW JSW Energy limited for the period 01.04.2024 to 31.03.2025.

ANNUAL CERTIFICATION OF ASH PONDS AND DYKES AND ANNUAL COMPLIANCE AUDIT OF ASH GENERATION, UTILIZATION & DISPOSAL

REPORT OF THE ASH DYKE STABILITY

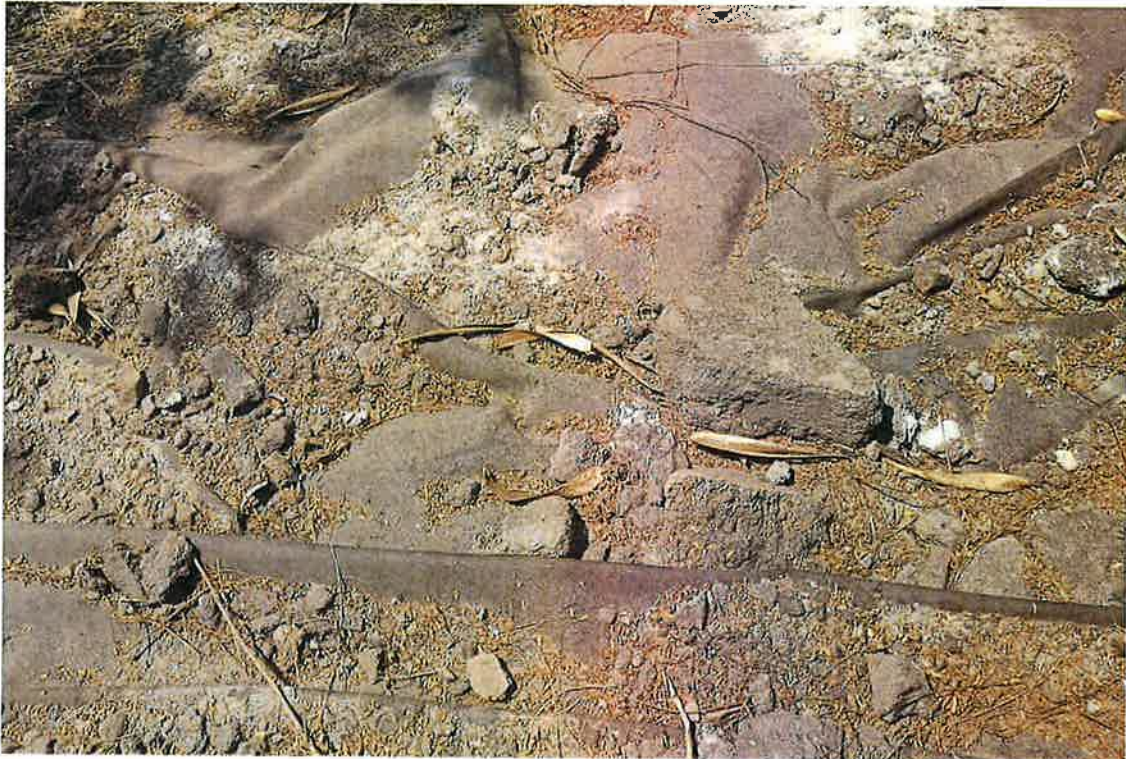
Hence, the soil samples were collected as per the borehole constructed for monitoring of the seepage. During field visit it was observed that HDPE membrane has been provided for storage pond. The membrane has been covered with soil and boulders of 1.0 to 1.2 m depth. At certain points it has been exposed, hence it was advised to cover it with soil and boulders (Figure 3). However, no puncture or crack was observed in the HDPE sheet.

Figure 3. Exposed impermeable HDPE membrane around the ash pond

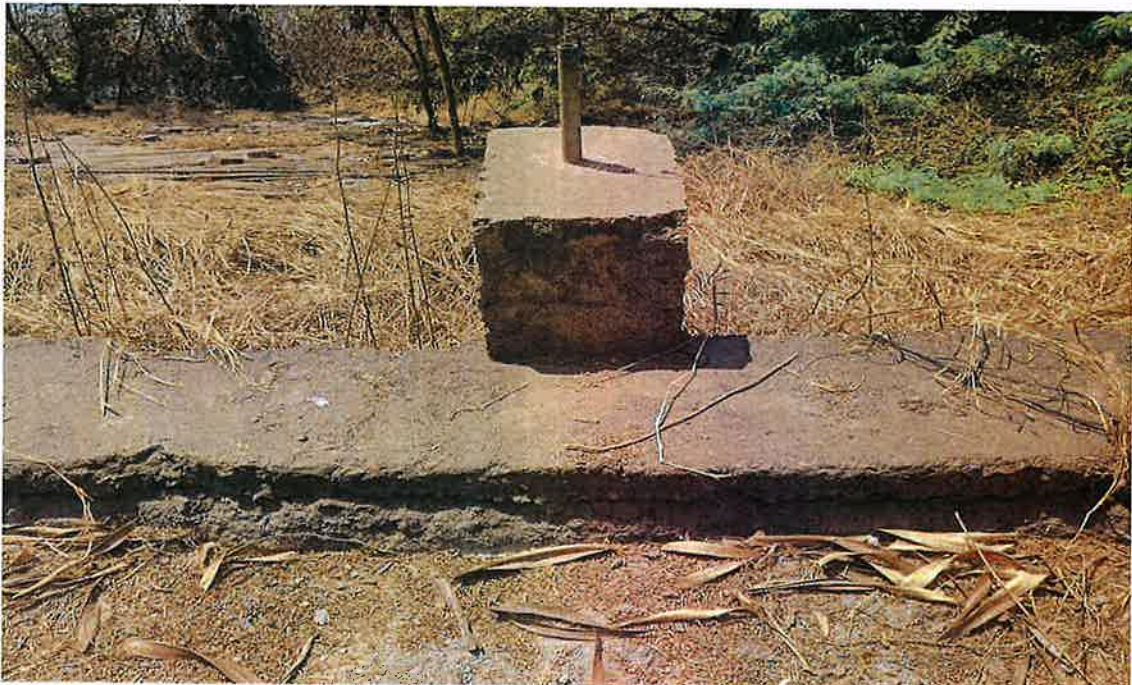
The ash pond was found to be well engineered with CC road of 4.0 m width all around the pond. The ash pond is also provided with water sprinkler system to suppress the fly ash and they are connected with ring water supply pipe lines all around the ash pond. This is evident from the concrete stand with pipes (Figure 4).

Figure 4. The sprinkler system stand pipe adjacent to the CC road

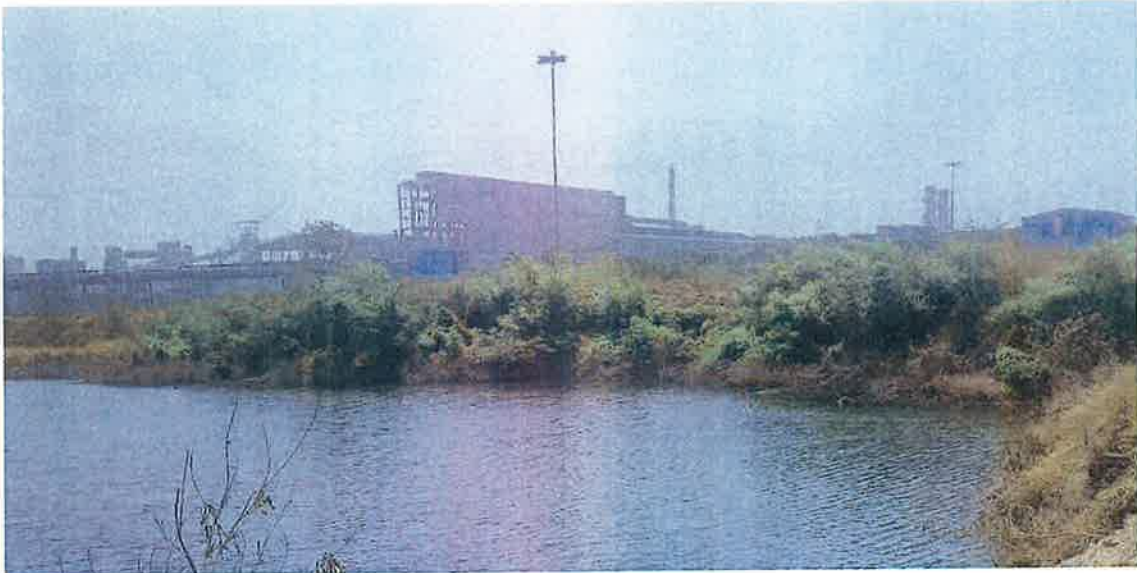
As the ash pond is without any fly ash and stores mostly with rainwater of approximate 1.67 m depth (Figure 5). There is also a high mast light for the lighting of the ash pond as shown in the figure. There are green vegetation of the downstream side of the ash pond on 3 sides, which helps the environment. It was also observed that there is a pipe network system (seem not being used for some time) to bring extra rainwater from nearby pond to store the rainwater as evident from Figure 6.

Figure 5. A general view of the ash pond with water level of approximate 1.67 m during the visit

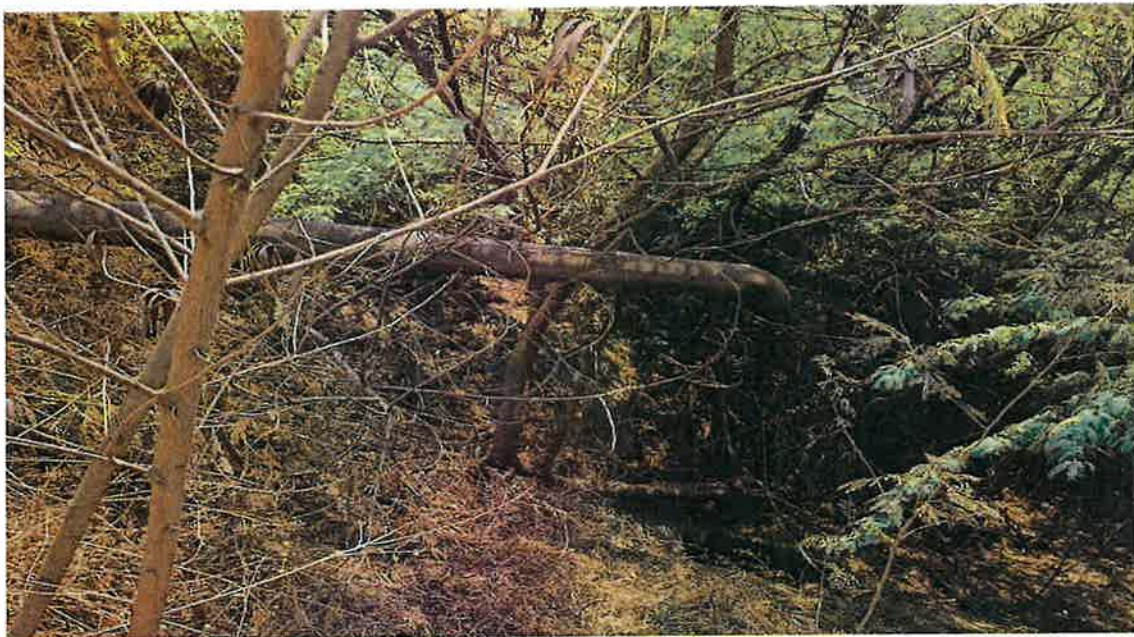
Figure 6. Pipe network for using the ash pond for the storage of rain water

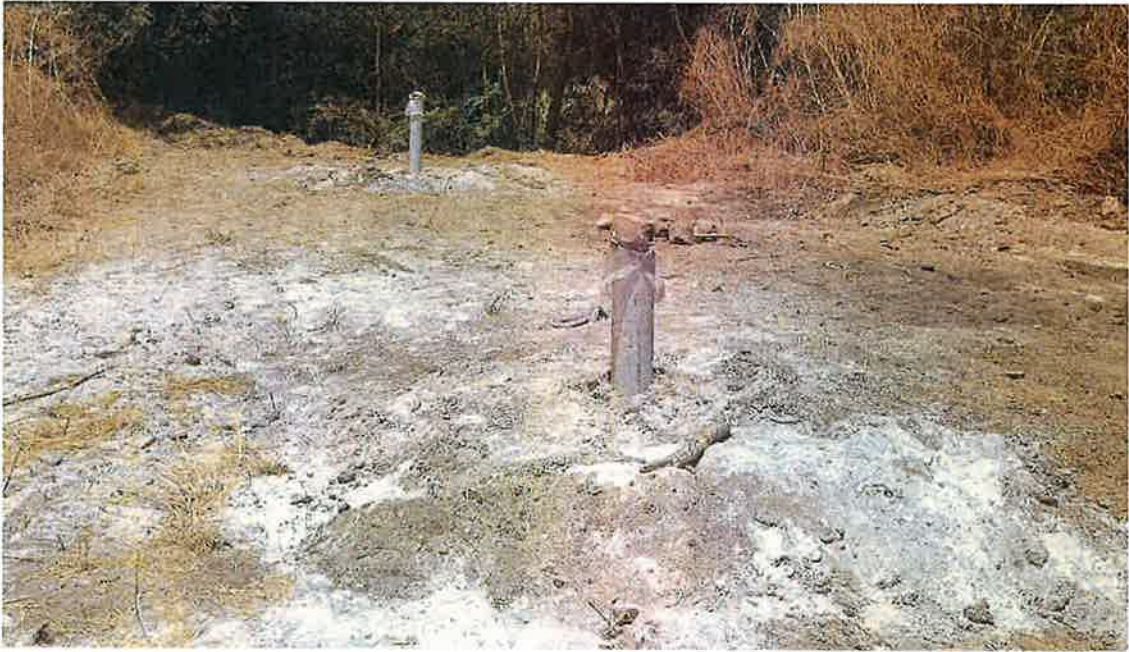
Though the ash pond is provided with HDPE sheets, but as per the standard guiding seepage monitoring is being done with 4 monitoring well made on the crest and downstream of the slope as shown in Figure 1. Two typical monitoring boreholes are shown in Figure 7.

Figure 7. Two seepage monitoring well

- It is recommended that the seepage and settlement should be monitored regularly.

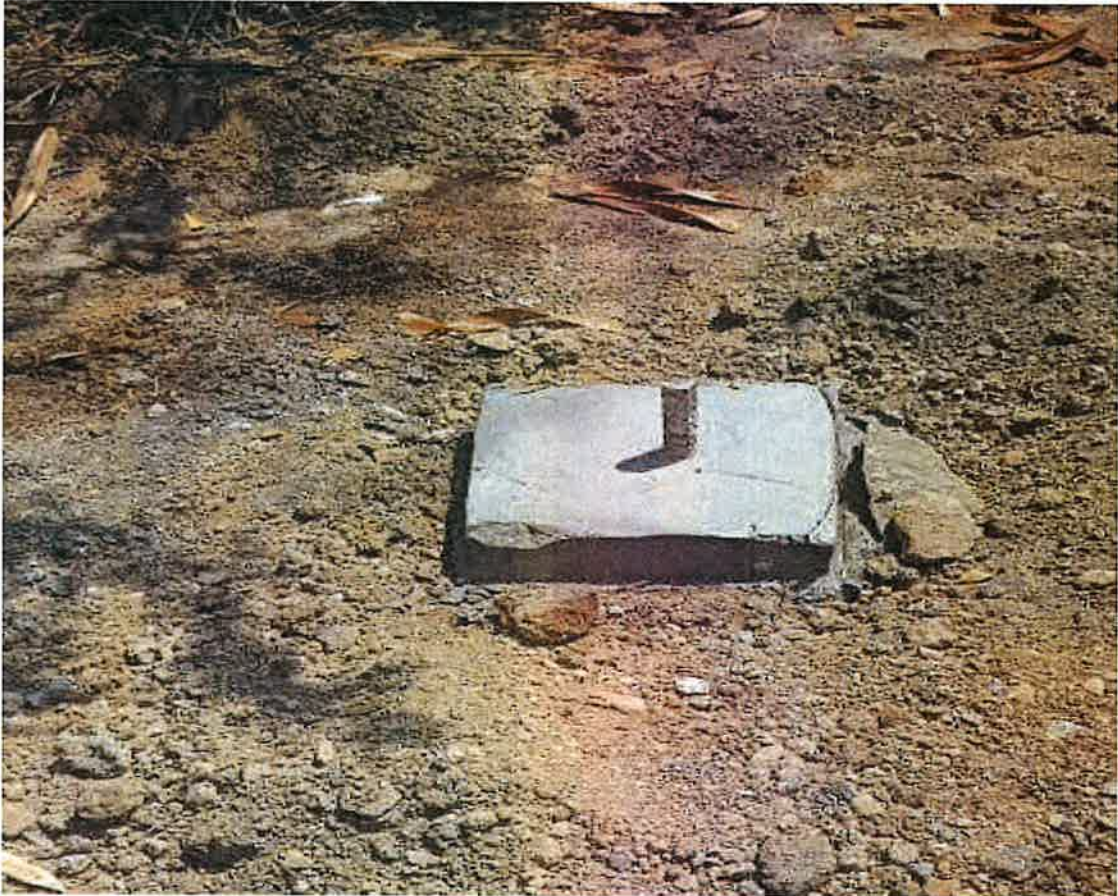
Similarly, two settlement monitoring stations have been put to measure the settlement of the top of the ash dyke as shown in Figure 8.

Figure 8. Settlement monitoring point

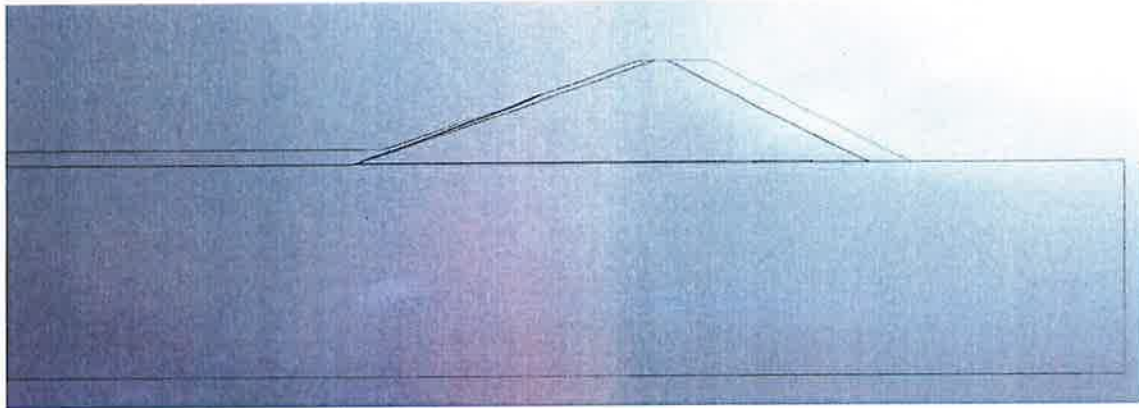
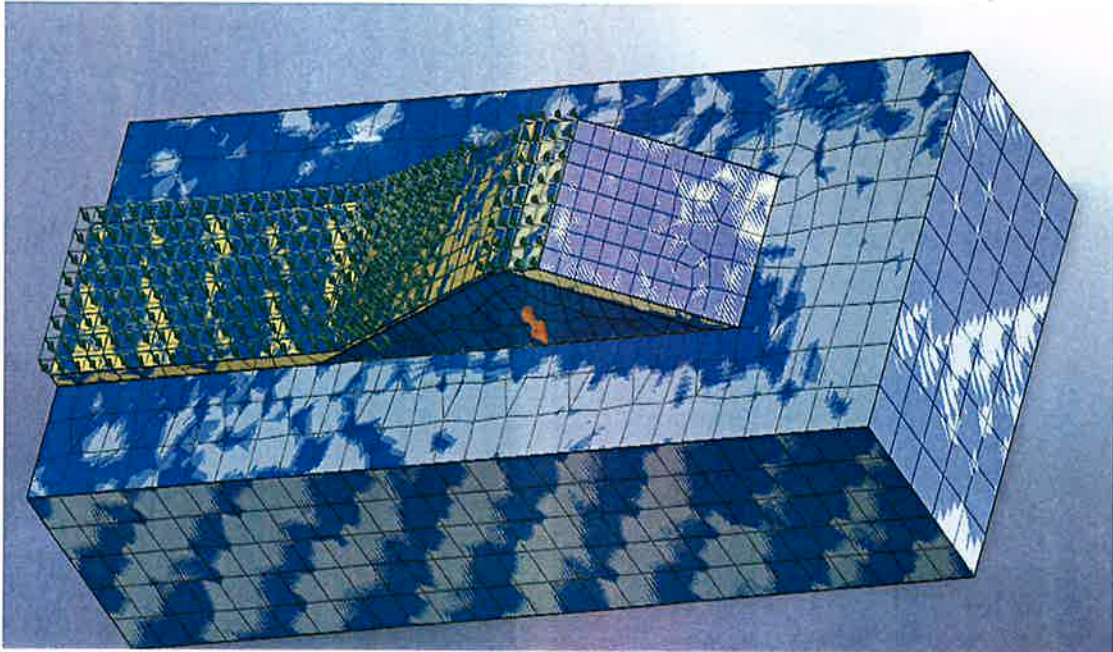
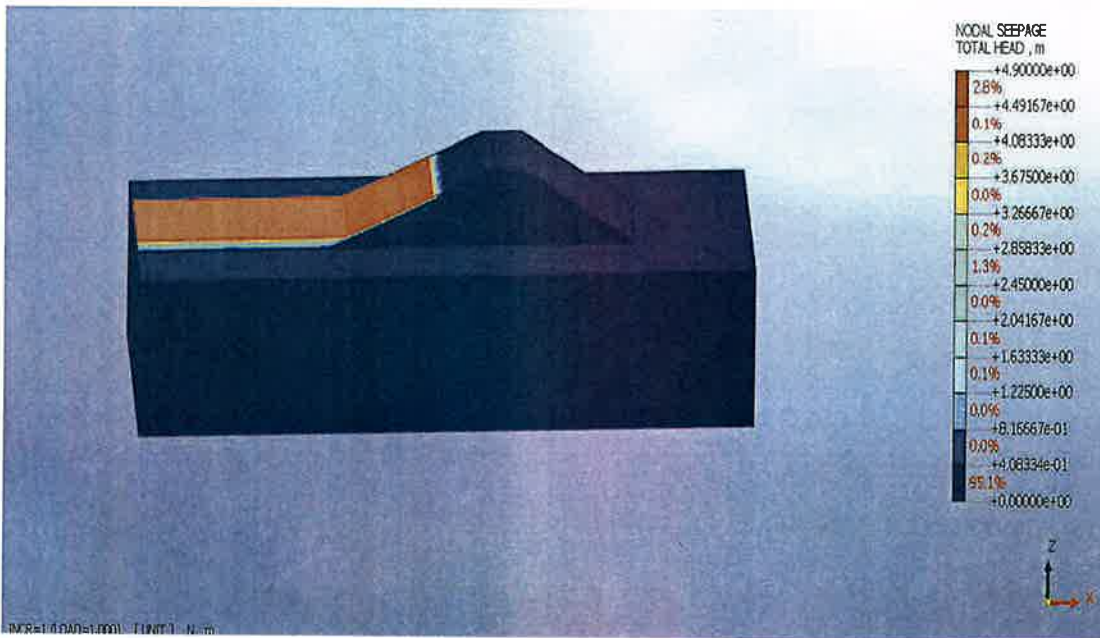
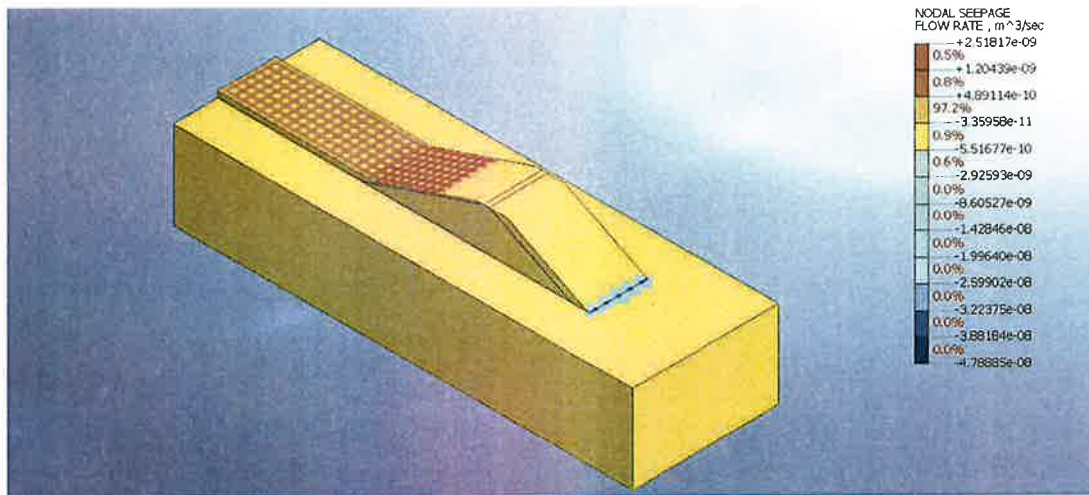
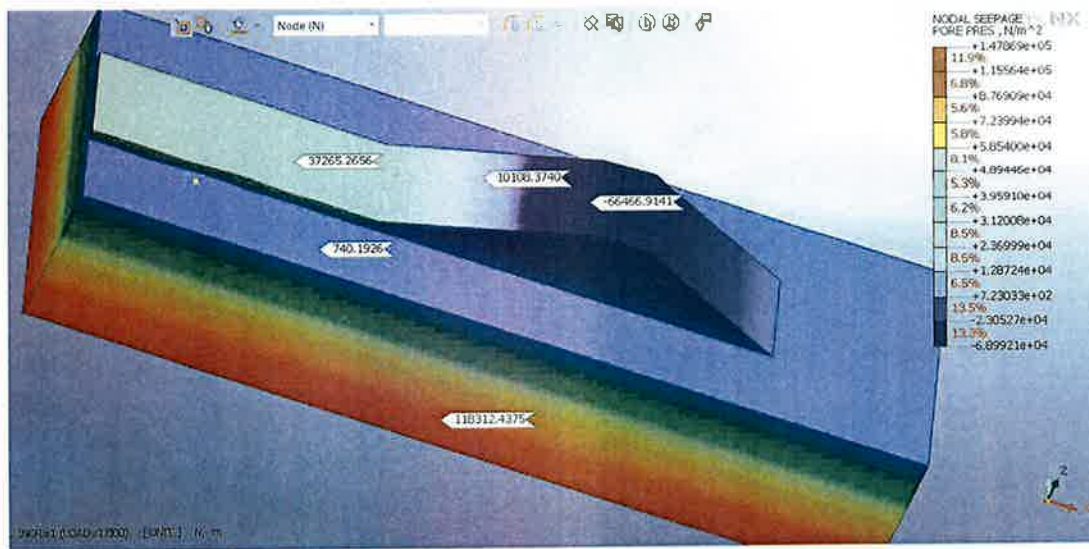
Figure 9. The flow through the ash dyke as per MIDAS GTS NX analysis

As there may be variation in the water level throughout the year, a variation of water depth of 1.7 m, 4m, 6m are used for both seepage analysis and stability of slope analysis. It was observed that there is negligible discharge of 4.78×10^{-8} m³/sec. During visit and as per record no discharge was observed around the ash dyke as there is HDPE as liner.

Note: Flow through embankment is very negligible.

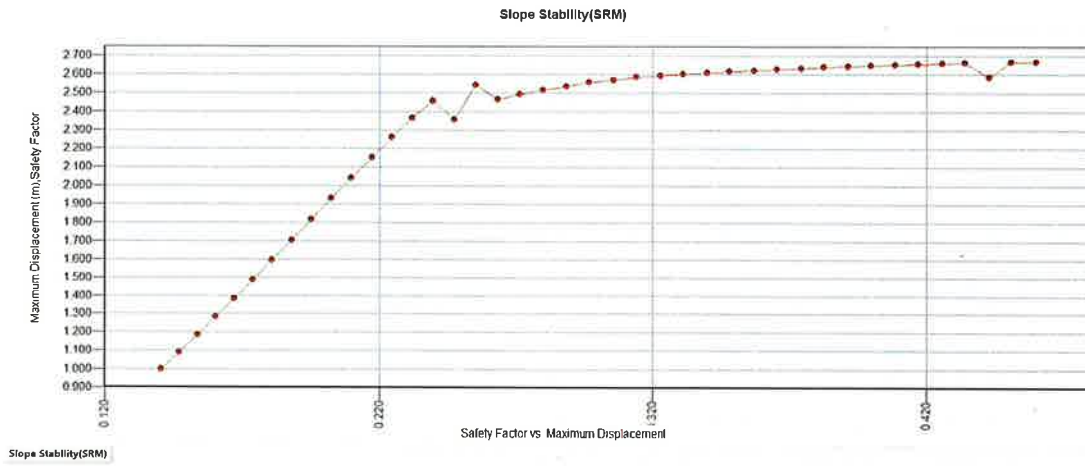
The slope stability analysis was made as per the geotechnical properties shown in Table 1 and considering a vehicle wheel load on the top of dyke as 2.5 kN/m². The Factor of Safety (*FoS*) was found to 2.66 as shown in Figure 10. After Application of all these loads it was also observed that the deflection only 42 mm (Figure 11), hence, the ash dyke is safe.

Figure 10. The FoS of the slope as per MIDAS GTS NX analysis with FoS value as 2.66

- The laboratory geotechnical properties soil is generally silty sand. The slope stability analysis in the worst case with vehicular load on the embankment of ash dyke showed a FoS of 2.66. Hence, the ash dyke is safe.

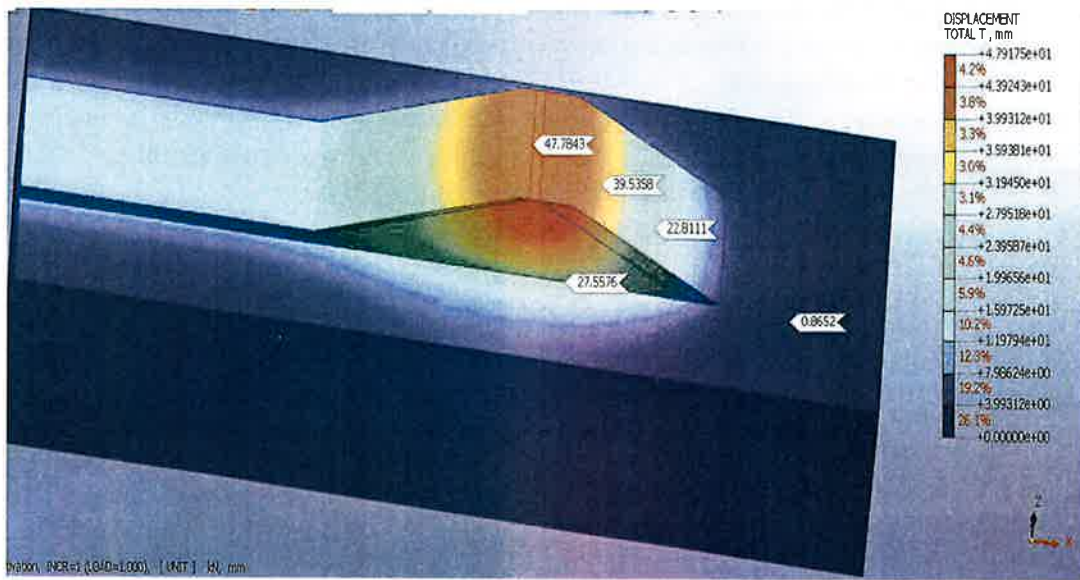
Figure 11. Maximum vertical deflection is 47.9 mm as per MIDAS GTS NX analysis
