Project No: JB00986

**REPORT**  
**On**  
**Condition Assessment**  
**Of**  
**400 kV, 120 kN Silicone Rubber Insulator**

**JSW-JPTL**

**By**  
**Root Cause Analysis Group**  
**Electrical Research and Development Association**  
**Vadodara**

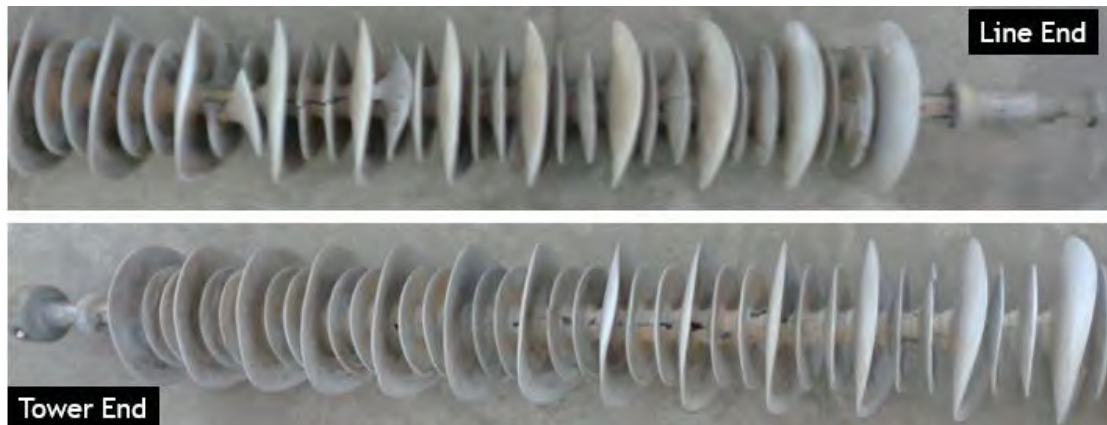
As received failed insulator is shown in Figure 2.2. The silicone rubber housing was found broken and separated from the composite rod on the entire length of insulator. Figure 2.3 shows both ends of insulator, it is tri-junction where composite rod, silicone rubber and metallic end fitting are joined together. Silicone rubber seal at both the tri-junction was found broken and composite rod showed tracking marks. Metallic end fitting at the tower end shows indications of arcing related overheating.

Figure 2.2: As received failed insulator (SRI-1) at the line end and tower end

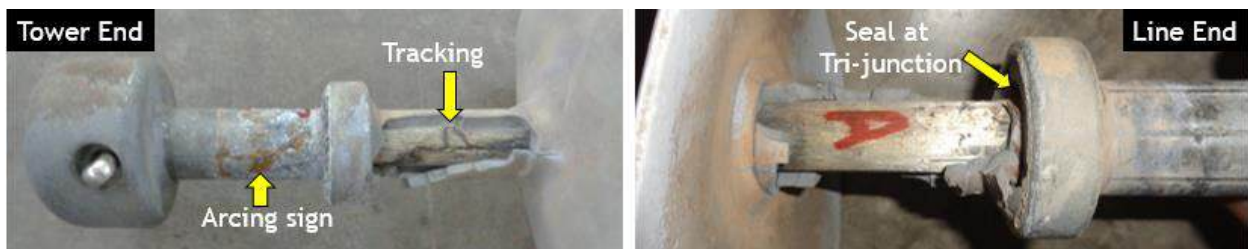
Figure 2.3: As received failed insulator (SRI-1) at the line end and tower end. Yellow arrow indicate arcing damage to the tower end metallic end fitting

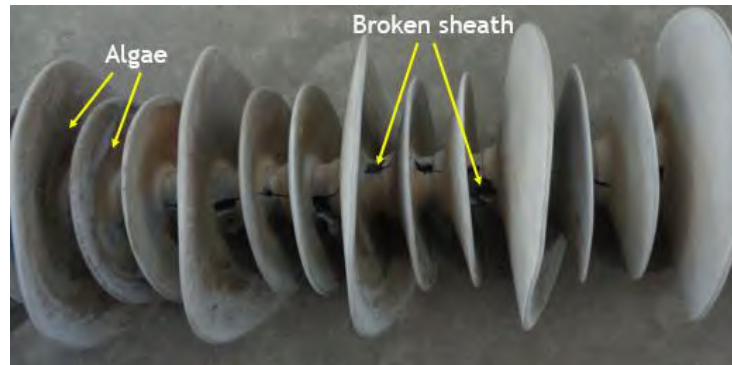
Figure 2.4 shows the central part of the failed insulator (SRI-1), the silicone rubber is broken as several places. The silicone rubber shades are covered with algae. The silicone rubber

Figure 2.4: Central part of the insulator showing broken silicone rubber housing. The silicone rubber shades are covered with algae

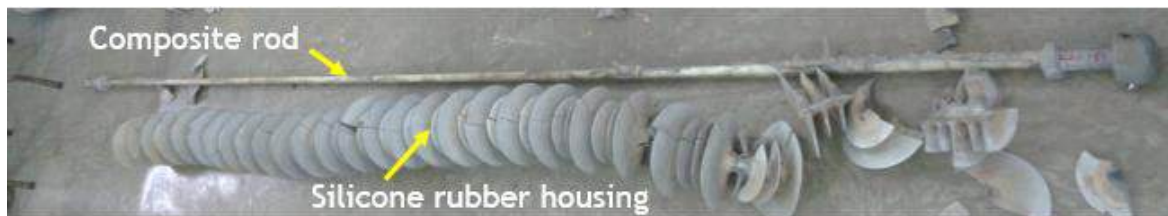
housing was removed from the SRI-1 as shown in Figure 2.5. The silicone housing was easily removed from the insulator indicating weak bonding between the composite rod and silicone rubber sheath.

Figure 2.5: Failed insulator silicone housing separated from the composite rod

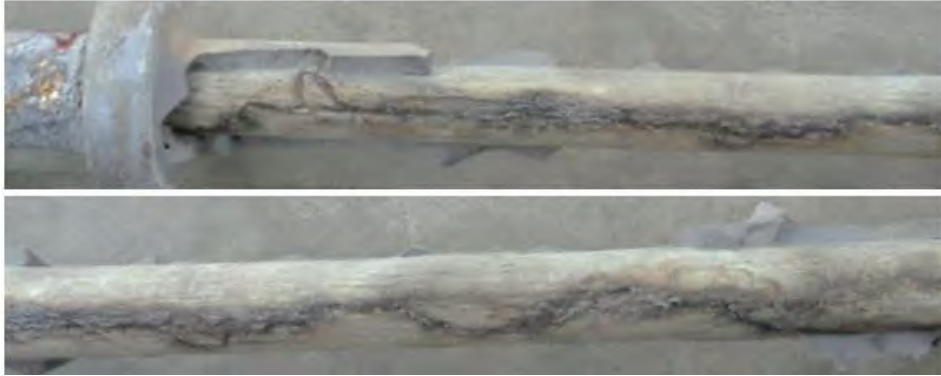
Figure 2.6 shows bare composite rod sections after removal of silicone rubber housing. Electrical tracking marks (black lines) are clearly visible on the composite rod surface. The tracking also penetrated deep in the composite rod resulting in wide crack in the composite rod. Figure 2.7 shows the silicone rubber shades, the smooth interface with composite rod is visible in the photograph indicating very weak bonding with the composite rod. The silicone rubber shade was also covered with large amount of algae and dust particles.

Figure 2.6: Failed insulator silicone housing separated from the composite rod

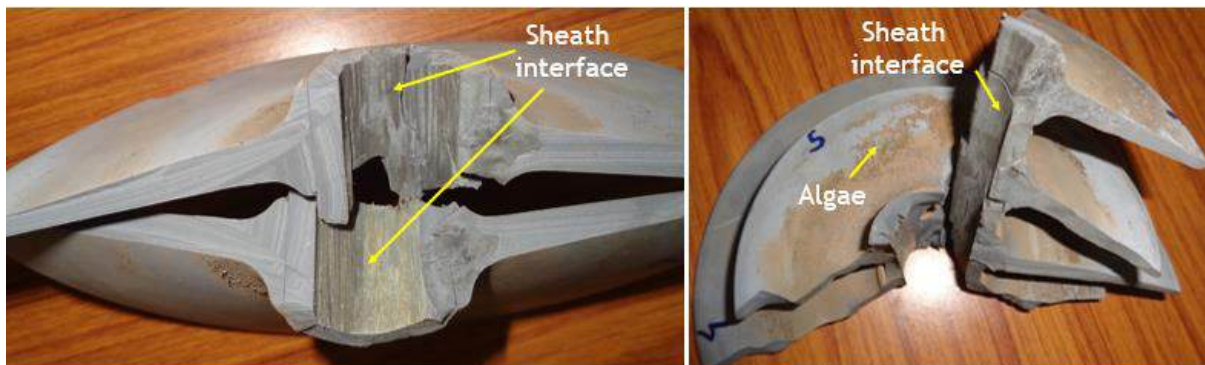
Figure 2.7: Failed insulator (SRI-1) silicone rubber housing removed from the insulator. The interface with composite rod is smooth

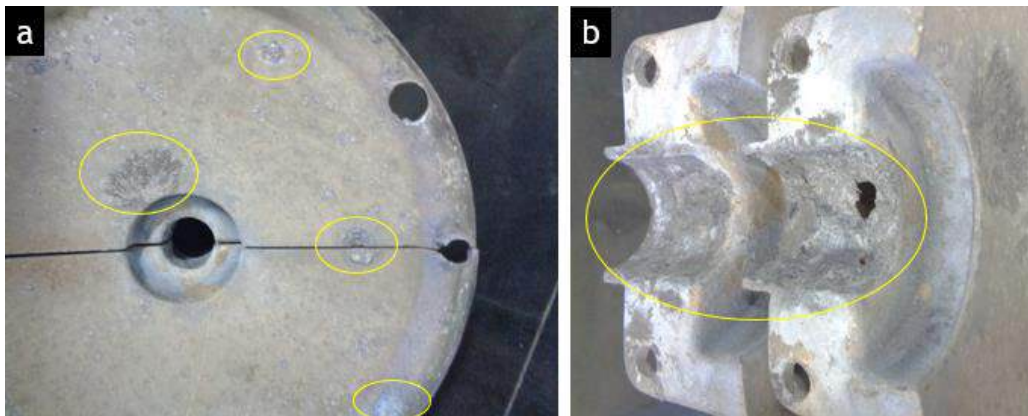
Figure 2.8 and 2.9 shows the corona rings at on tower end and line end, respectively. The tower end corona ring shows number of arcing marks and the coupling area attached to insulator is highly damaged. It indicated high temperature damage due to arcing. The corona ring at the line end showed relatively few arcing marks compared to the tower end corona ring.

Figure 2.8: Corona ring on tower end showing arcing marks (metal is damaged) - a) corona ring surface and b) joint area with insulator is damaged due to arcing related melting (arcing marks are indicated in yellow)

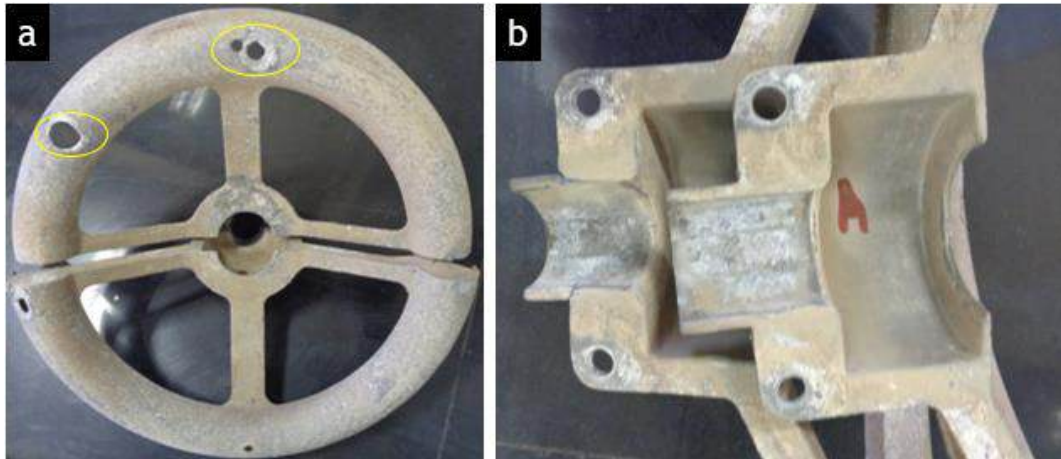
Figure 2.9: Corona ring on line end showing arcing marks (metal is damaged) - a) corona ring surface and b) joint area with insulator is damaged due to arcing related melting (arcing marks are indicated in yellow)

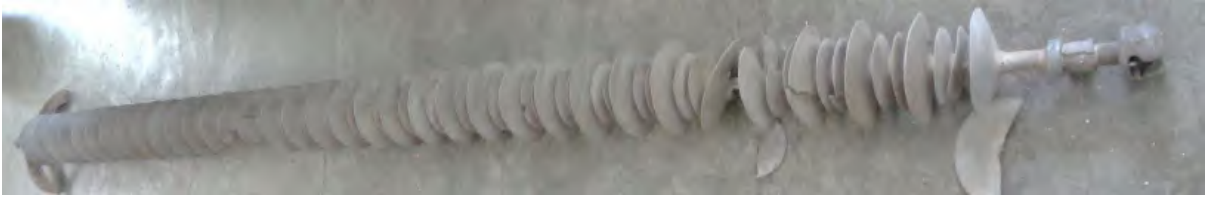
As received failed insulator is shown in Figure 2.10. Similar to SRI-1 for entire length of insulator the silicone rubber housing showed cracks and showed weak interface with composite rod. Tower end corona ring of insulator was not received and line end corona ring was broken. The broken corona ring did not show arcing damage. Figure 2.11 shows both ends of failed SRI-2, at the line end the silicone rubber sheath is broken. On tower end the silicone sheath was undamaged. Arcing related damage was not visible on both ends.

Figure 2.10: As received failed insulator (SRI-1) at the line end and tower end

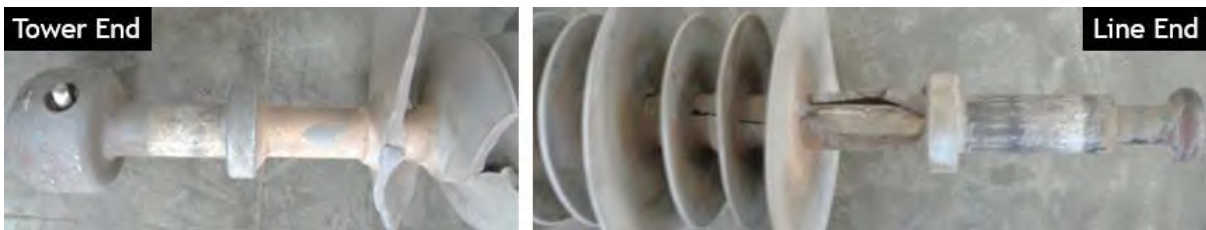
Figure 2.11: Both end of insulator the silicone shades are broken, silicone rubber seal at both ends are not directly affected

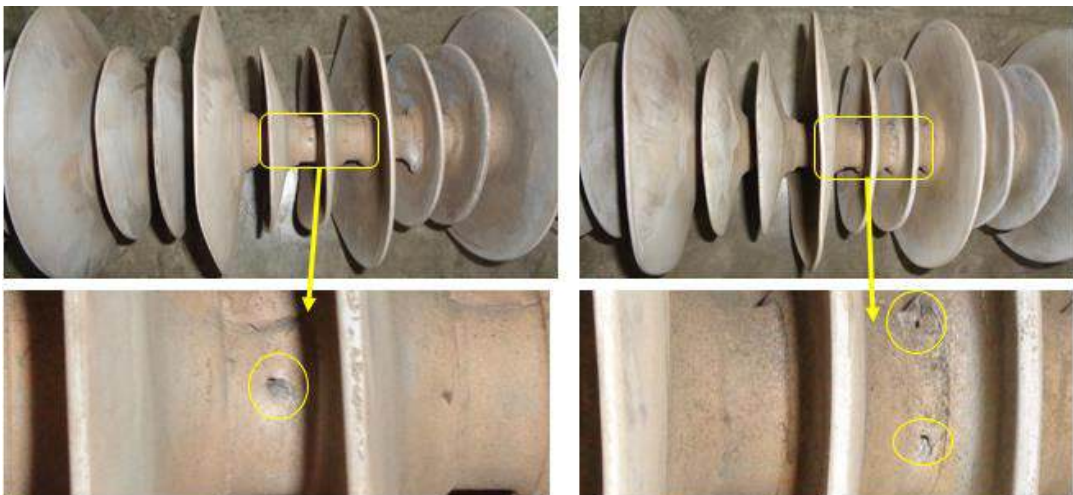
Figure 2.12 shows the silicone rubber housing, punctures were visible on the silicone rubber sheath. The silicone rubber shades and sheath was covered with algae in dust. Figure 2.13 shows punctures in different sections of insulator. Several punctures were found on line end as well as tower end of insulator. The punctures on tower end indicate enhanced electric field on both ends of insulator.

Figure 2.12: Silicone rubber housing of SRI-1 showed several punctures, bottom picture are enlarged section of highlighted area of top pictures

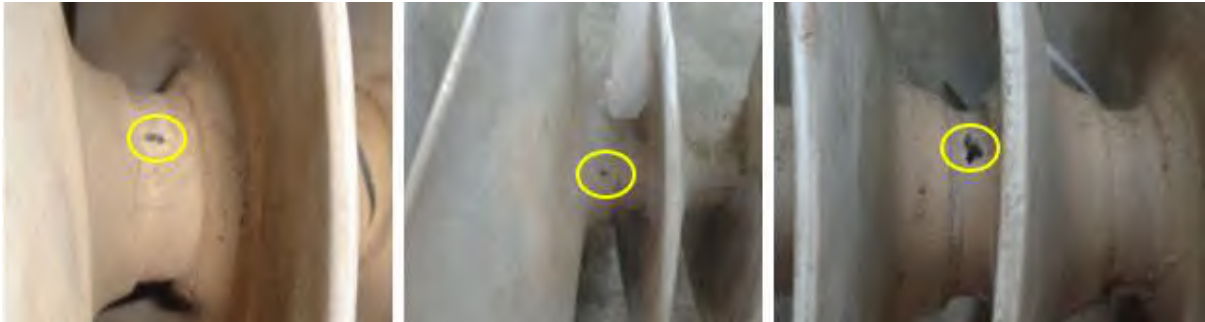
Figure 2.13: Punctures observed in different sections of SRI-2 insulator

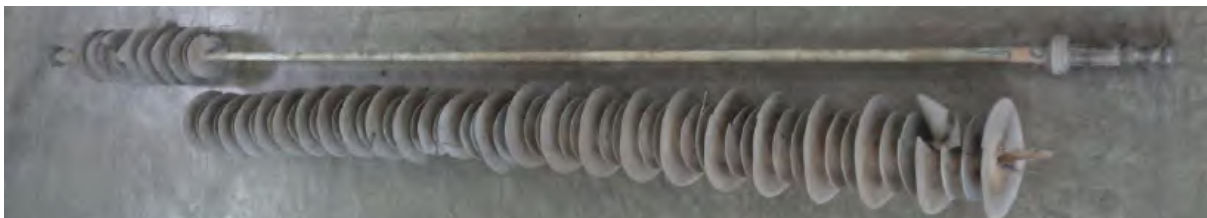
Figure 2.14 shows silicone rubber housing removed from the composite rod. The housing was easily separated from the composite rod indicating weak interface with the composite rod. The composite rod under the housing showed tracking marks on entire length of insulator.

Figure 2.14: Silicone rubber housing removed from failed SRI-2

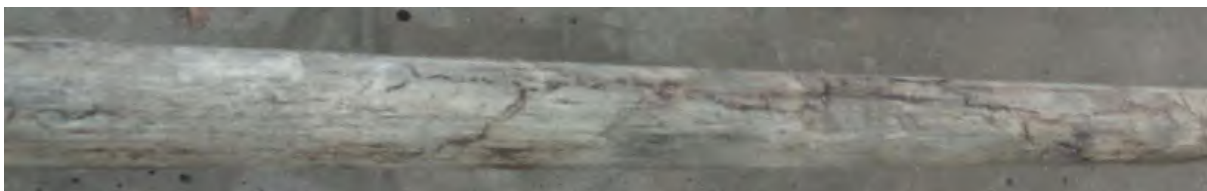
Figure 2.15: Tracking marks were found on entire length of composite rod from SRI-2

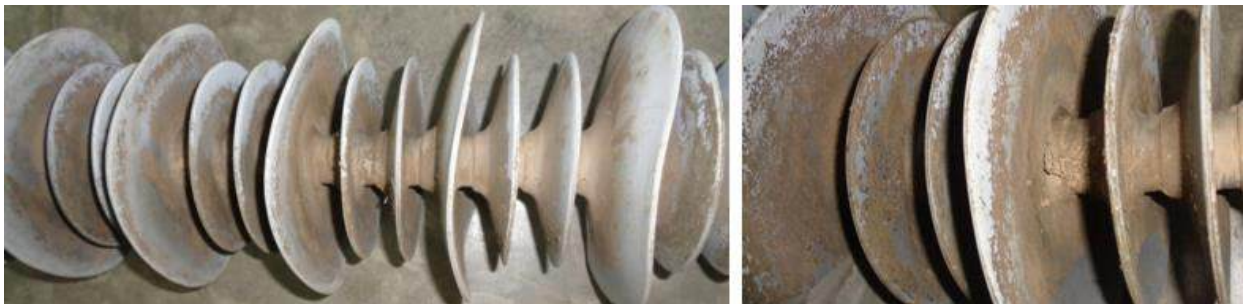
Figure 2.17: Most of the silicone rubber housing was covered with algae

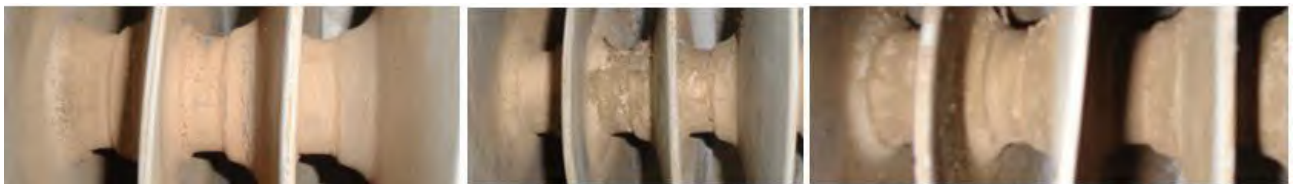
Figure 2.18: Silicone rubber sheath mostly covered with dust and algae but no punctures

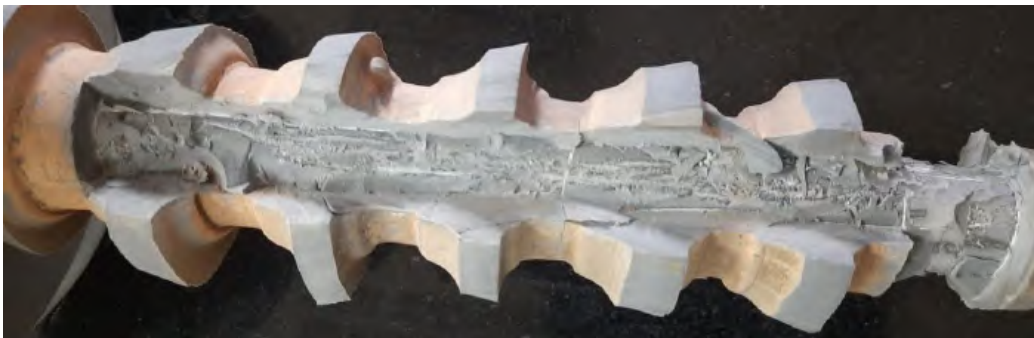
Figure 2.20: Stripe test on SRI-3, the interface was found good

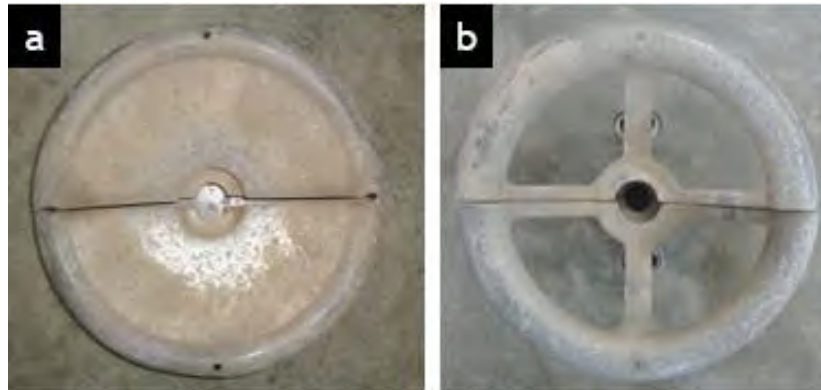
Figure 2.21 shows the corona ring from SRI-3. The tower end corona ring surface is covered with algae. Line end corona ring is relatively clean on the outer surface. The corona ring covered with dirt/algae (insulating material) may not function properly to reduce the electric field on the insulator.

Figure 2.21: Corona rings: a) tower end and b) line end

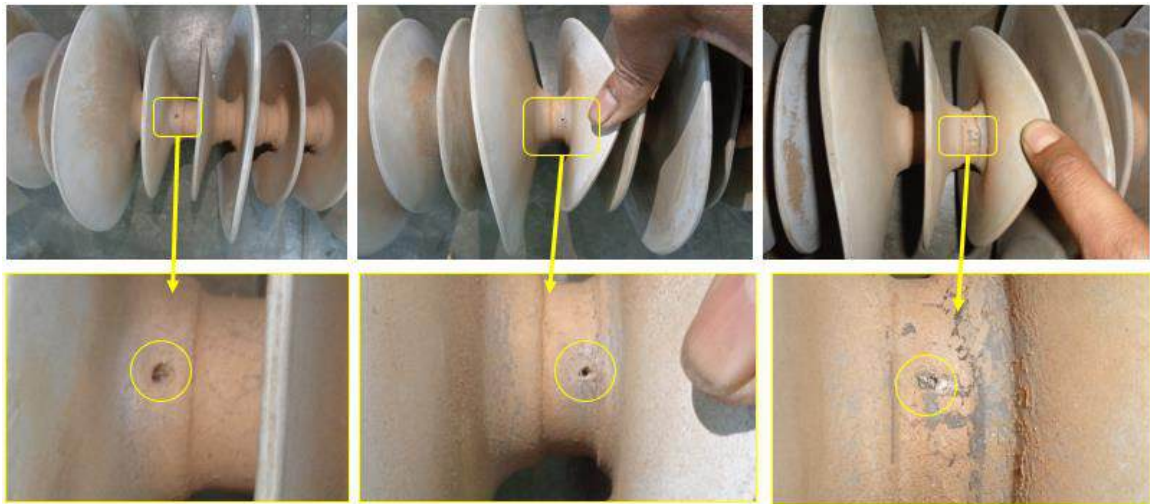
Close observations of silicone rubber sheath of SRI-4 showed several punctures as shown in Figure 2.25. The punctures were observed up to 90 cm from the line end of insulator. The tower end section did not show any punctures. To closely observe the punctures, the silicone rubber shades from the insulator section was removed. The puncture in different sections of the insulator is shown in Figure 2.26.

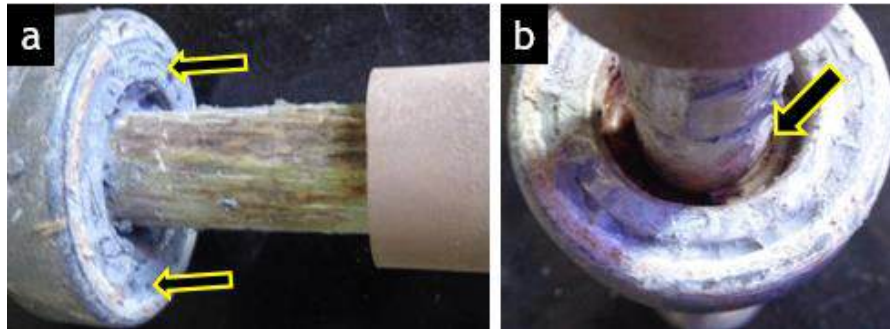
Silicone rubber from seal at the tri-junction was removed for visual analysis as shown in Figure 2.28. The area under the seal did not show any indication of water/moisture entry.

Figure 2.28: a) Area under the seal at tri-junction and b) area inside the tri-junction

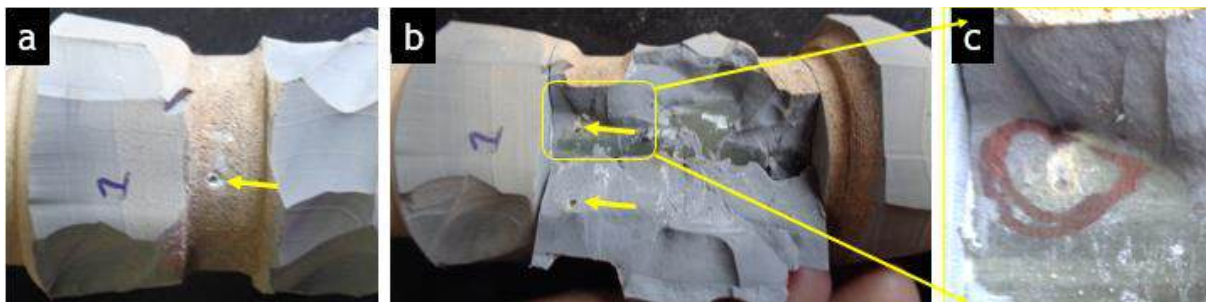
Silicone rubber sheath above the puncture was removed, refer Figure 2.29. The silicone rubber or the composite rod under the puncture did not show major degradation. Another puncture area, shown in Figure 2.30 showed degraded composite rod underneath. The last puncture was approximately 90 cm away from the tri-junction, near shade number 26 as shown in Figure 2.31. Composite rod under the puncture was degraded and exact back side of the composite rod was intact with good adhesion. Whenever there was degradation of composite rod, the area silicone rubber sheath was easily removed showing weak interface. Otherwise the interface was found strong.

Figure 2.29: a) puncture near shade-1, b) interface area under the puncture and c) enlarged area under the puncture, just beginning of degradation of composite rod

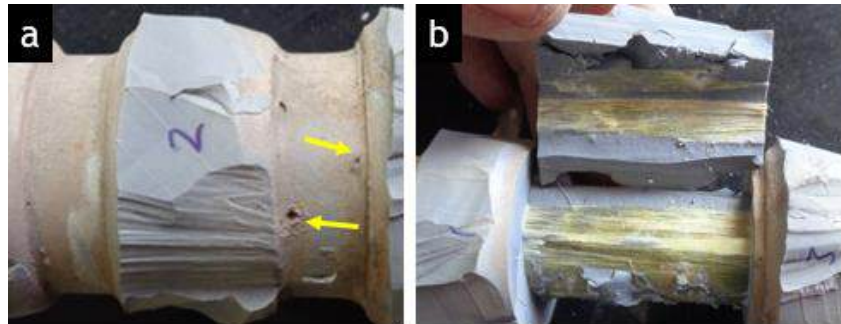
Figure 2.30: a) Two puncture visible near shade number 2 and b) interfacial area under the puncture is degraded

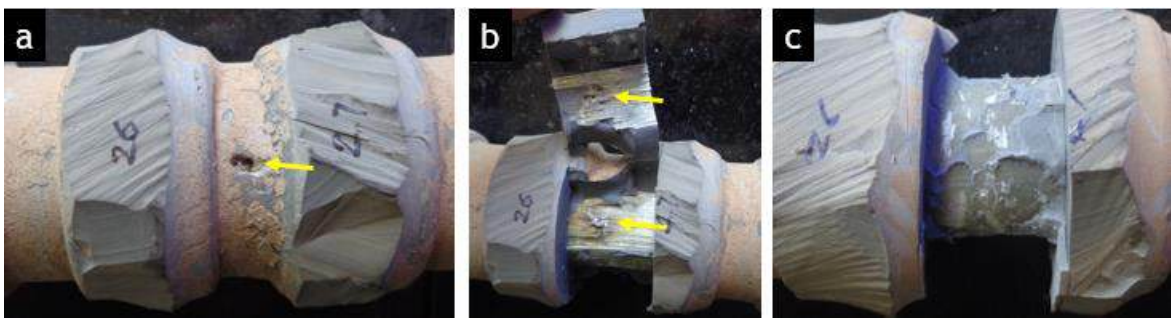
Figure 2.31: a) A puncture visible near shade number 26, b) interfacial area under the puncture is degraded and c) back side of the rod was found intact

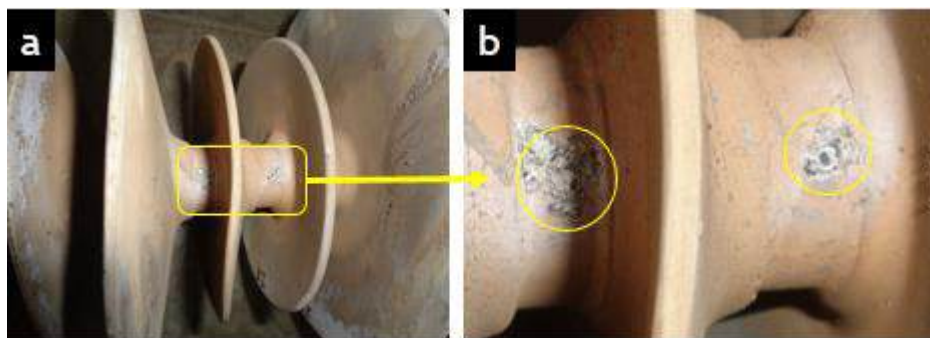
Figure 2.33: Silicone rubber sheath was puncture between the shade numbers 25 to 27

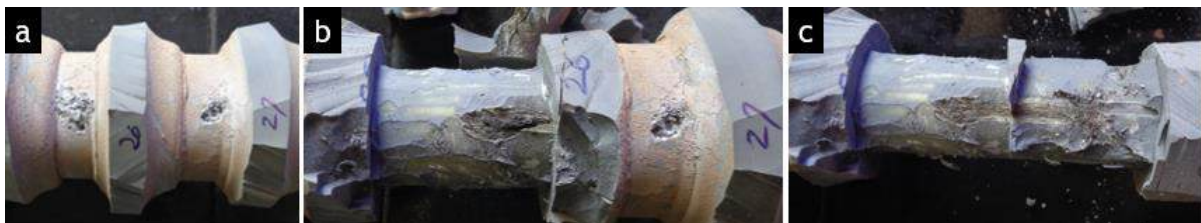
Two punctures were observed in silicone rubber sheath between shade numbers 25 to 27. The sheath from punctured area was removed to evaluate the state of composite rod. The degradation was found localized near the punctured area as shown in Figure 2.36. Adhesion between silicone rubber and composite rod in surround area of puncture found good.

Figure 2.36: a) Punctured sheath, b) composite rod under first puncture and c) composite rod under the second puncture

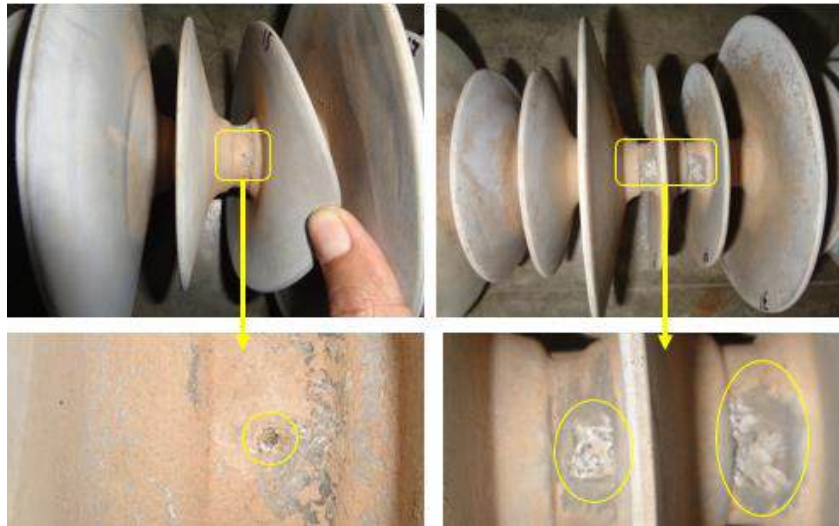
The silicone rubber sheath showed number of punctures up to 90 cm distance from the tri-junction at line end. Some of the punctures in the silicone sheath is shown in Figure 2.40. To analyze punctured sheath, shades from the insulator section was removed as shown in Figure 2.41. The punctures in various section of insulator are visible.

Figure 2.40: Silicone rubber sheath showed punctures, magnified view in the bottom photographs

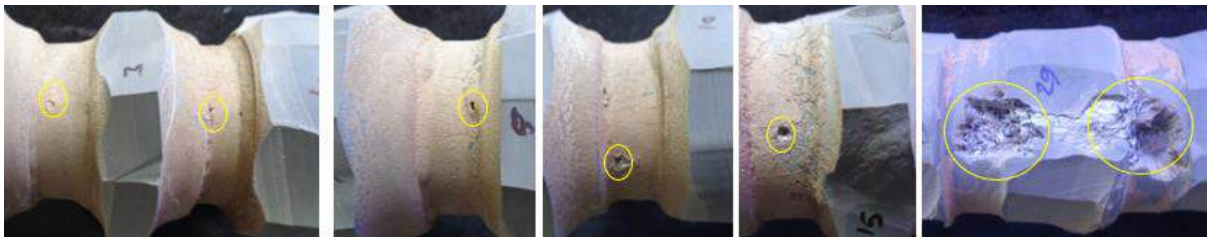
Figure 2.41: Punctures visible in silicone rubber sheath after removal of shades from SRI-6

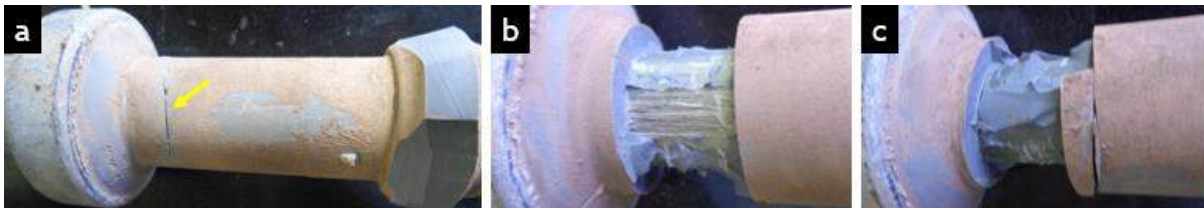
Figure 2.42 a shows the insulator section near metallic end fitting showing a crack. To evaluate the composite rod under the sheath, the silicone rubber was removed from the section. Near the cracked sheath the composite rod was found degraded, refer Figure 2.42 b. Only small area of the composite rod near the tri-junction was degraded, rest of the composite rod was in good condition, refer Figure 2.42 c. It appears that the composite rod is only degraded covering 20% of circumference and spread in axial direction as confirmed by stripe test, refer Figure 2.43. Two punctures found at approximately 90 cm from tri-junction from line end are shown in Figure 2.44 a. Degradation underneath the puncture was very much localized indicating recent initiation of degradation. Interface in strength by stripe test in surround area was found good.

Figure 2.42: a) crack visible near the tri-junction at line end, b) sheath removed, composite rod is degraded and c) rest of the composite rod is intact near the tri-junction

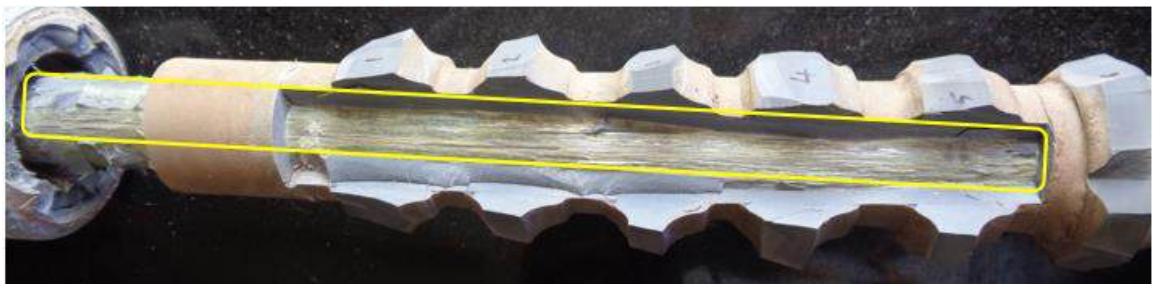
Figure 2.43: Stripe test on puncture sheath in axial direction, composite rod is degraded on one axial direction

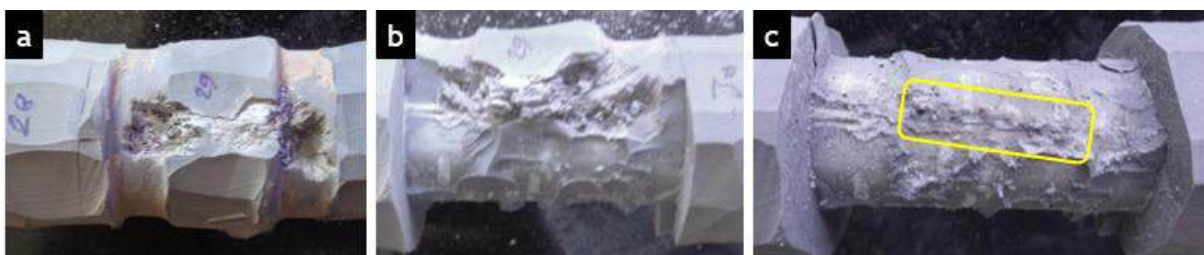
Figure 2.44: a) Punctured sheath, b) degraded silicone rubber and c) composite rod degradation found localised (highlighted in yellow border)

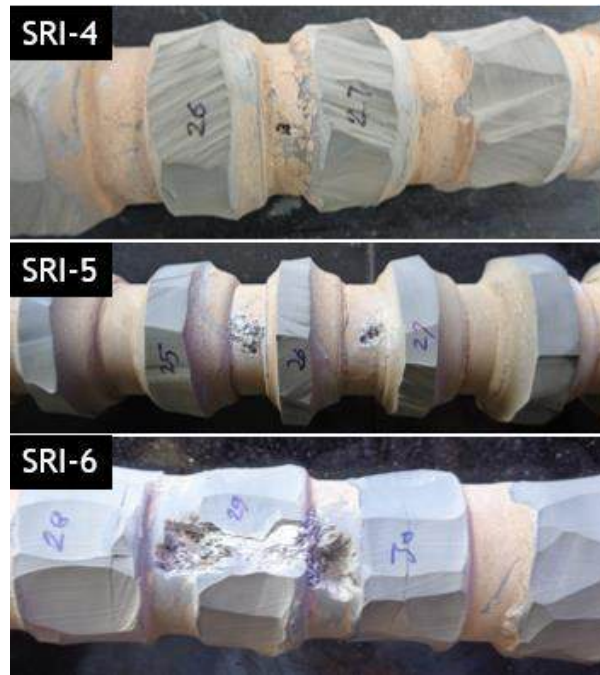
For working insulators, removed from service, punctures were found only on the line end of insulators with last puncture at 90 cm from tri-junction. All the three working insulators showed punctures at distance 85 cm to 90 cm (between shade numbers 25 to 30). Punctures observed at this location are larger in size than the other punctures observed on the insulators, refer Figure 2.45. This indicated that enhanced electrical stresses up to 90 cm from tri-junction at line end.

Figure 2.45: Punctures found in three working insulators removed from the tower

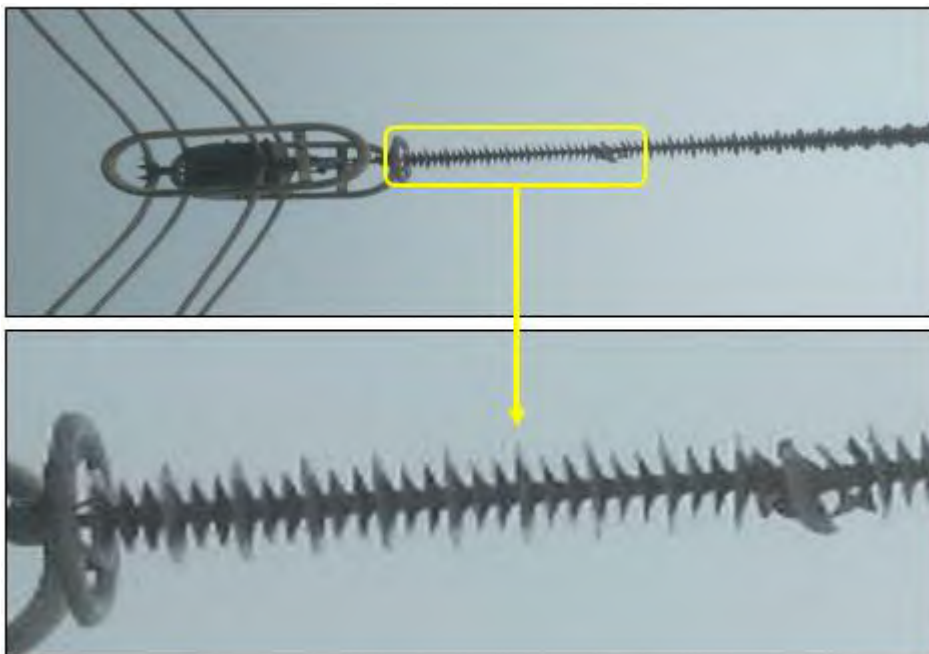
Also, the failed insulator (SRI-2) also showed damage at around 90 cm from line end in the photo shared from site. All this indicated enhanced localized electrical stresses at line end of insulators.

Figure 2.46: Failed insulator photo from site, the major damage appears near shade number 30

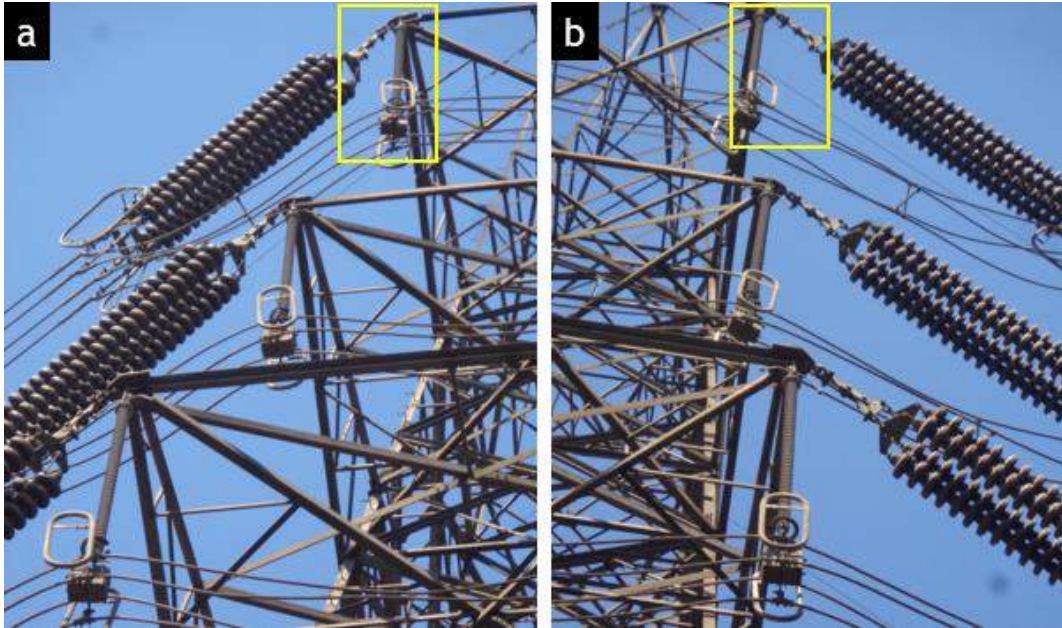
One failed and two service insulators on Jaigarh end of the tower 151 showed punctures indicating enhanced electrical stresses. On the Jaigarh end the angle between porcelain tension insulator and suspension composite insulator appeared small compared to Karad end of tower. This results in closer proximity of line end of porcelain insulator to the composite insulator leading to enhanced electrical field. Such enhancement of the e-field was also confirmed by FEM analysis. The high e-field punctured the silicone rubber housing leading to water ingress inside the composite insulator resulting in progressive degradation and failure of the insulator.

Figure 2.48: Two side of tower 151 showing porcelain insulators connected with conductors on a) tower 150 and b) tower 152 side. The angle between porcelain and composite insulator is different on both sides (highlighted in yellow rectangle)

It is recommended to increase the angle between porcelain and composite insulator on Jaigarh end. The algae deposits on the insulators, corona rings and arcing horns should be cleaned periodically. Periodic monitoring with IR and UV camera shall be carried out to detect hot spots or corona activity. It is recommended to install surge arrester on the transmission tower to minimize damage due to lightning strikes.

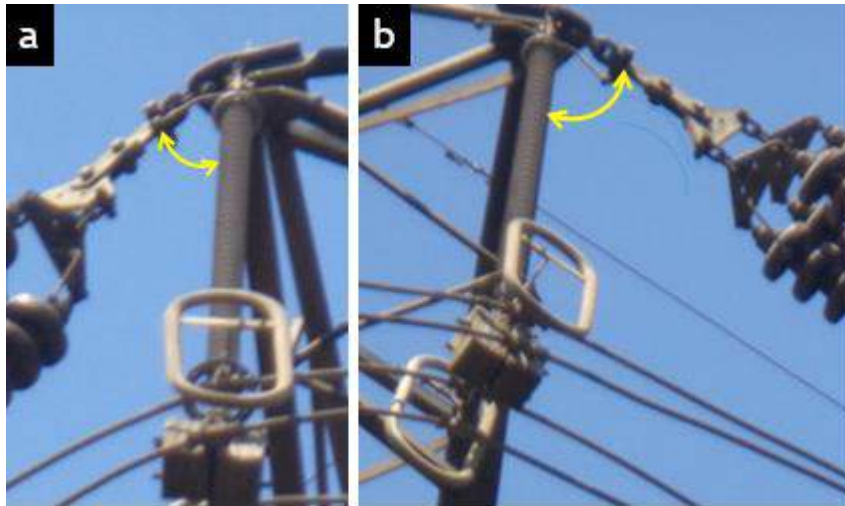
Figure 2.49: Photographs showing angles (indicated by yellow) between porcelain insulator with composite insulator at tower end on a) tower 150 side and b) tower 152 side.
