Project No: JB00986

**REPORT**  
**On**  
**Condition Assessment**  
**Of**  
**400 kV, 120 kN Silicone Rubber Insulator**

**JSW-JPTL**

**By**  
**Root Cause Analysis Group**  
**Electrical Research and Development Association**  
**Vadodara**

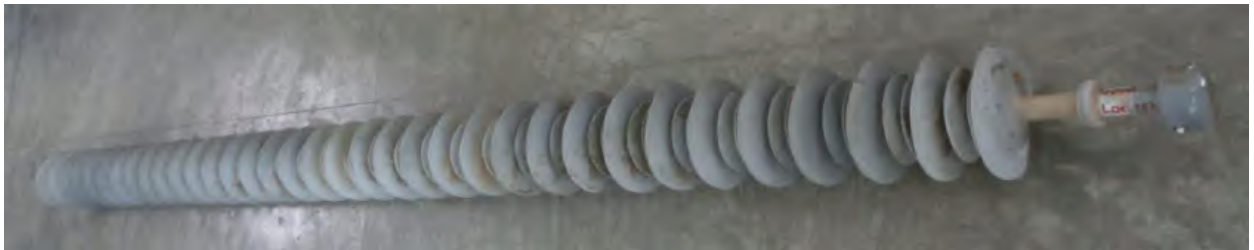
As received working insulator removed from same tower is shown in Figure 2.16. The working insulator did not show any damage. Figure 2.17 shows close view of silicone rubber housing, the housing is covered with algae. Figure 2.18 shows the enlarged view of silicone rubber sheath from different sections of SRI-3. Apart from algae and dust covering the sheath no visible damage or degradation is visible.

Figure 2.16: As received working insulator (SRI-3) received for analysis

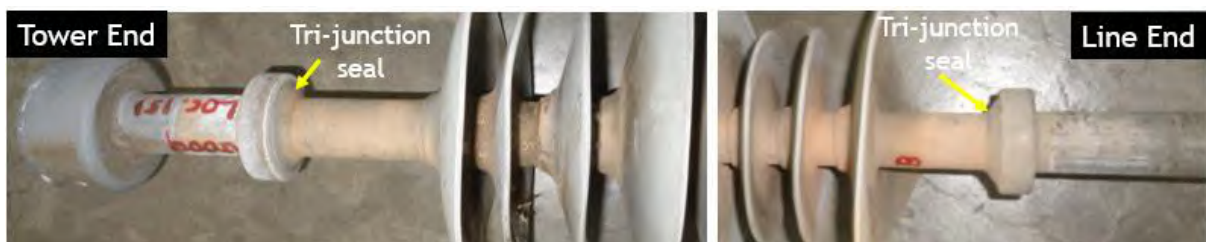
Figure 2.19 shows the silicone rubber seal at the tri-junction on both ends. No damage or degradation visible in the silicone rubber seal. To evaluate the interface between silicone rubber and composite rod, stripe test was conducted. Silicone rubber in axial and circumferential direction was cut and pulled out. Figure 2.20 shows the rough surface remaining after the pull out that the interface indicating good interfacial bonding between silicone rubber and composite rod.

Figure 2.19: End fitting with tri-junction seal of SRI-3

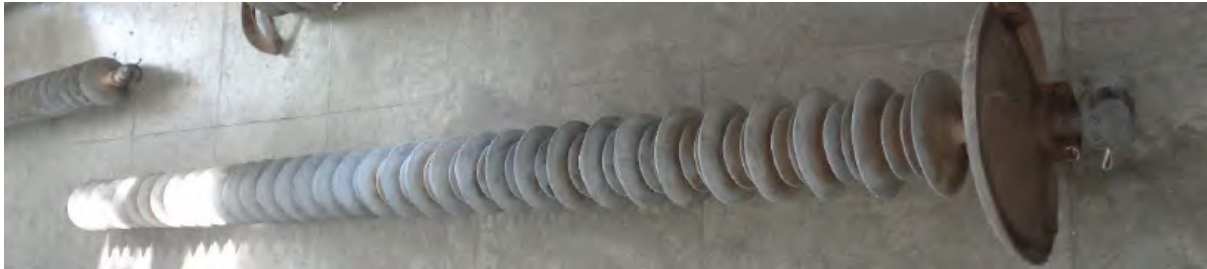
As received working insulator removed from same tower is shown in Figure 2.22. The working insulator received with one corona ring attached to it. Figure 2.23 shows close view of silicone rubber housing, the housing is covered with algae and dust. Figure 2.24 shows the insulator section near metallic end fittings at both ends. On the line end side the silicone rubber sheath near tri-junction shows a large crack.

Figure 2.22: As received working insulator (SRI-4) received for analysis

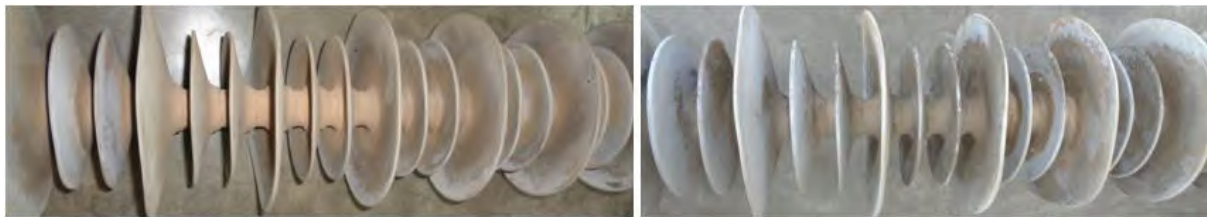
Figure 2.23: As received working insulator (SRI-4) received for analysis

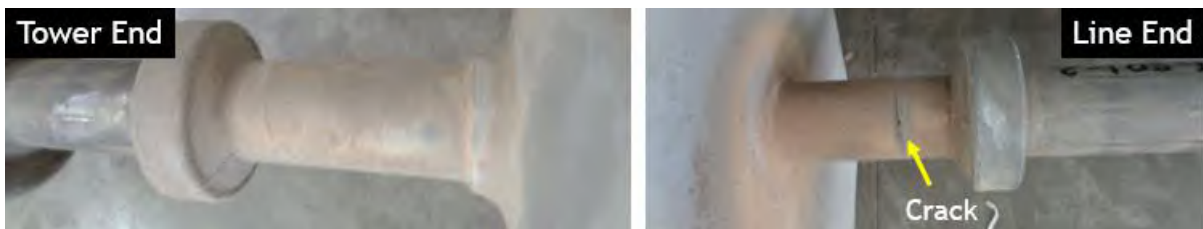
Figure 2.24: Silicone rubber seal at tri-junction with metallic end fittings

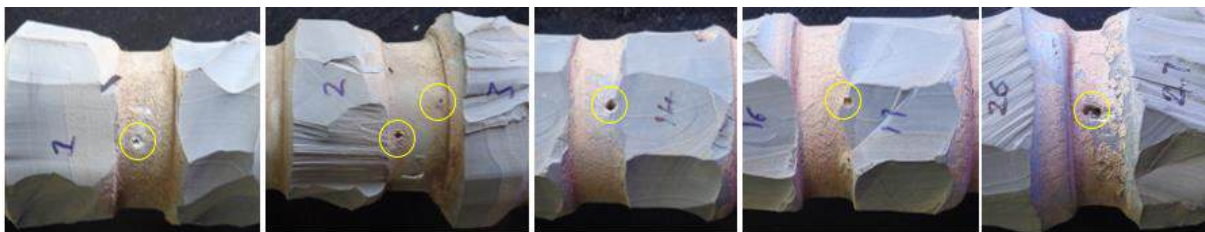
Close observations of silicone rubber sheath of SRI-4 showed several punctures as shown in Figure 2.25. The punctures were observed up to 90 cm from the line end of insulator. The tower end section did not show any punctures. To closely observe the punctures, the silicone rubber shades from the insulator section was removed. The puncture in different sections of the insulator is shown in Figure 2.26.

Figure 2.26: Silicone rubber seal at tri-junction with metallic end fittings

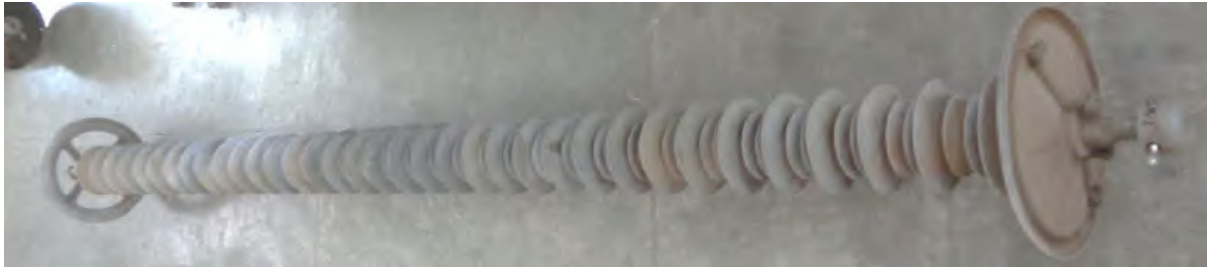
As received working insulator, SRI-5, removed from same tower is shown in Figure 2.32. The working insulator received with both corona rings attached to it. Figure 2.33 shows close view of silicone rubber housing, the housing is covered with algae and dust.

Figure 2.32: As received working insulator (SRI-5) received for analysis

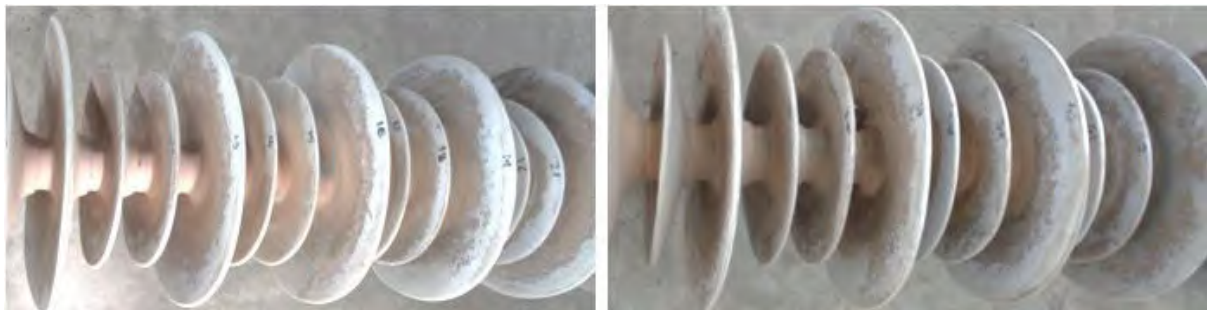
Figure 2.33: As received working insulator (SRI-5) received for analysis

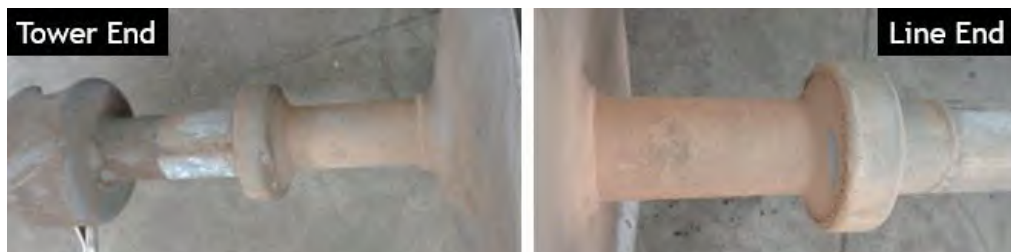
Figure 2.34 shows the insulator section near metallic end fittings at both ends. At both ends no visible damage or crack observed in silicone rubber sheath. However, the sheath is covered with large amount of dust. To evaluate the silicone rubber sealing at line end on insulator, the

Figure 2.34: Silicone rubber seal at tri-junction with metallic end fittings

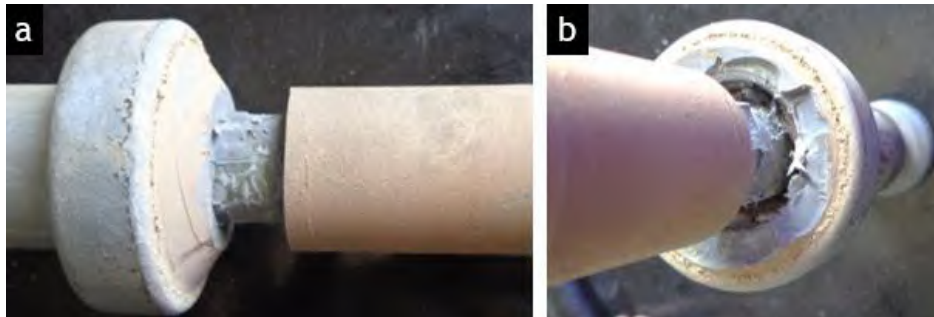
silicone rubber from the area was removed as shown in Figure 2.35. No indication of degradation and water penetration observed at the tri-junction.

Figure 2.35: Silicone rubber seal at the tri-junction on line end

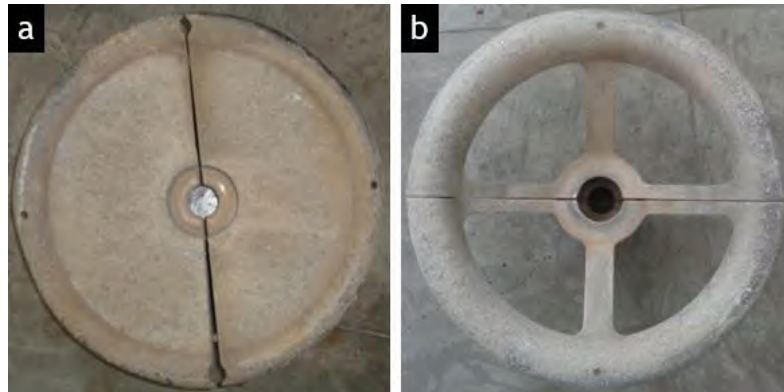
Corona rings from SRI-5 are shown in Figure 2.37 from both end of insulator. The tower end corona ring is covered with algae and dust particles.

Figure 2.37: Corona rings from SRI-5: a) tower end and b) line end

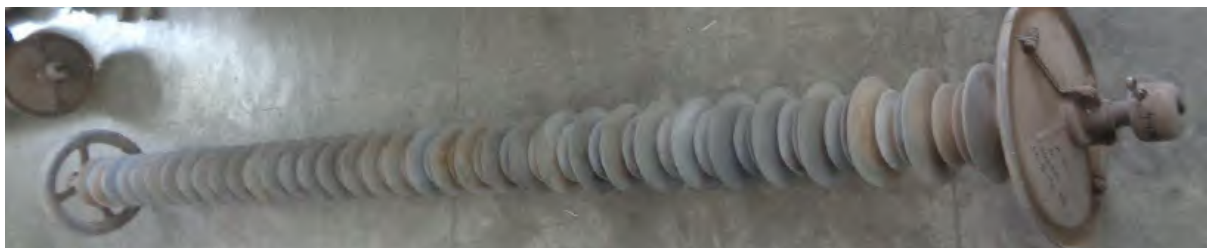
As received working insulator, SRI-6, removed from same tower is shown in Figure 2.38. The working insulator received with both corona rings attached to it. Figure 2.33 shows close view of silicone rubber housing, the housing is covered with algae and dust.

Figure 2.38: As received working insulator (SRI-6) received for analysis

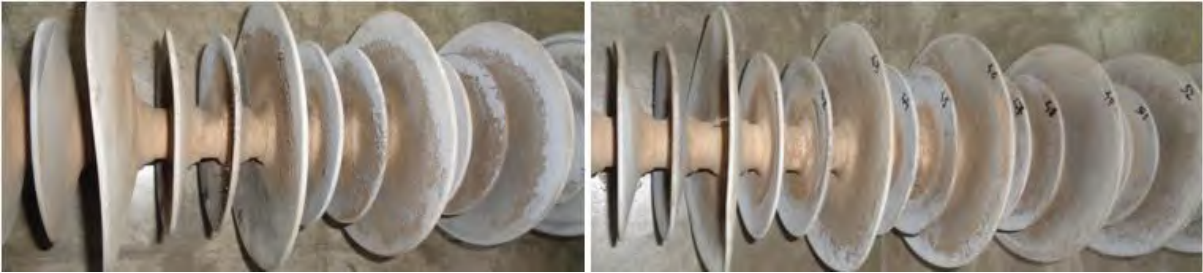
Figure 2.39: As received working insulator (SRI-5) received for analysis

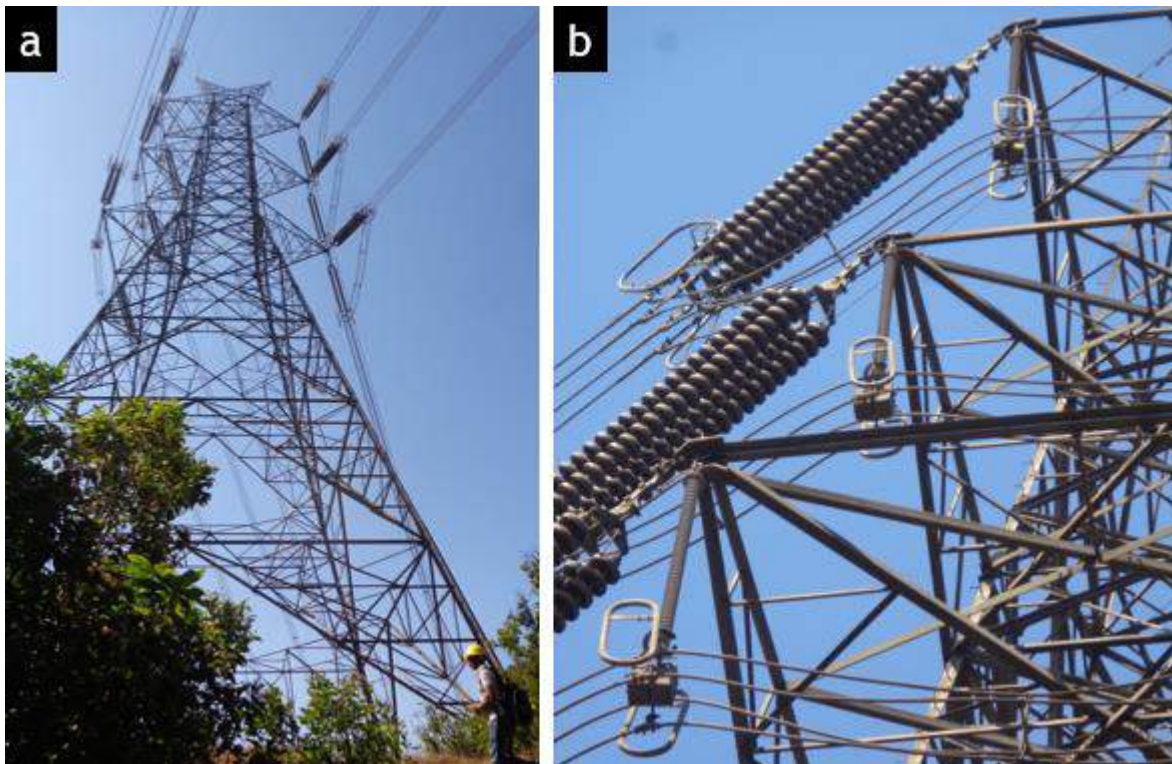
The two failed insulators were located on tower 151, the failure took place on the same tower twice. No other tower was affected by the insulator failure. Figure 2.45 shows the tower along with the porcelain suspension and silicone rubber composite tension insulators are visible. The electrical stress control accessories like corona rings at both end and arcing horns were correctly placed on the insulators. Damaged or broken stress control accessories were not found on the tower.

Figure 2.47: a) Tower no. 151 with the insulators and b) The suspension insulator and tension insulator located on the tower

The tower no. 151 is located in a forest area on hill with height approximately 2500 feet and suspension insulators were located at height of 250 feet on the tower. Therefore, the failed insulators were located approximately 2750 feet above sea level. The failed insulator were located at the highest elevation in the transmission line. Corona inception voltage is lower as the tower height increases, resulting in increased probability of corona discharges. The hilly terrain where the towers are located are under monsoon rain continuously for four months. Therefore, all the tower components including the insulators are normally covered with algae.

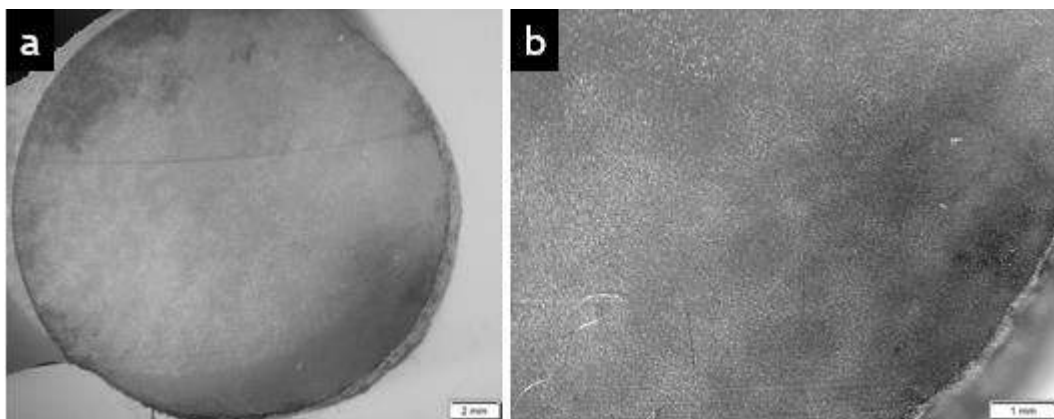
Figure 3.1 shows stereo microscopic images with different magnification for composite rod for failed insulator. The images does not show micro-crack in the composite rod indicating good quality of the rod. The interfacial area of the composite rod where tracking was observed in shown in Figure 3.2. Interfacial degradation and tracking marks are visible on the composite rod surface.

Figure 3.1: Stereo microscope images of composite rod section of failed insulator (SRI-1) with different magnification

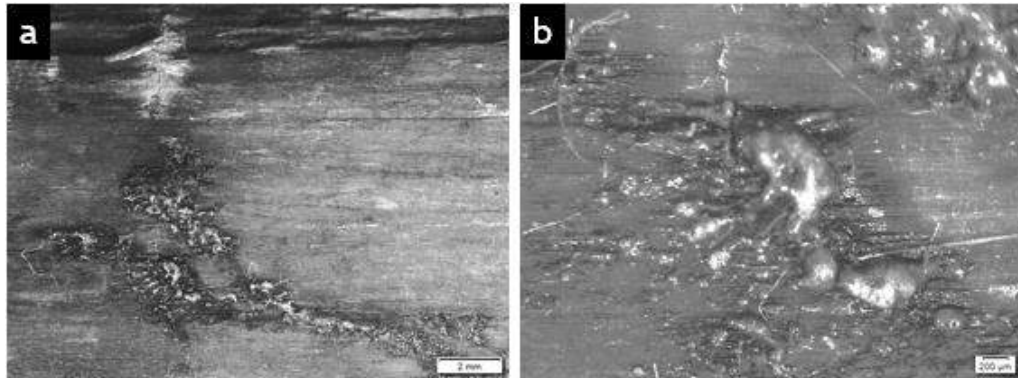
Figure 3.2: Stereo microscope images of interfacial area of composite rod from failed insulator (SRI-1) with different magnification

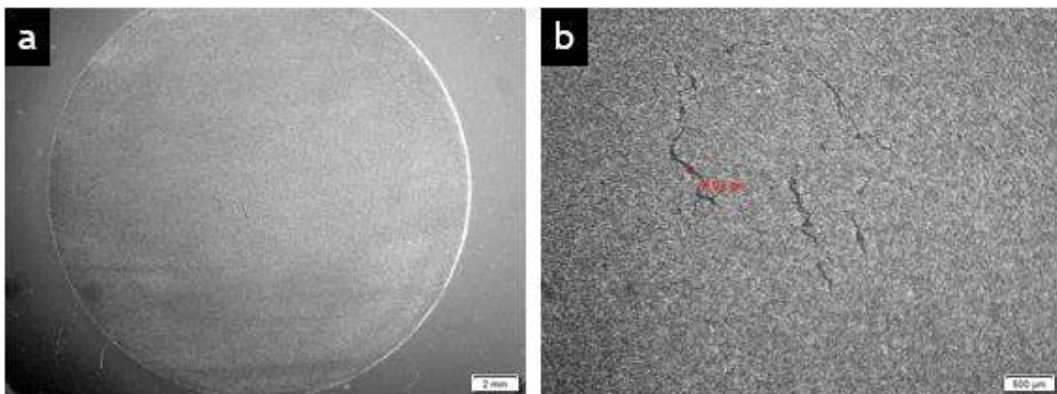
Figure 3.3 shows the stereo microscope images from working insulator (SRI-3), few micro-cracks in centre of composite rod was observed. The micro-cracks are not near the interfacial surface where it can cause puncture due to PD. Figure 3.4 shows microscopic images of SRI-4, for a section cut near the puncture. No microscopic crack is observed in the composite rod indicating that composite rod has not played a role in puncture of the sheath.

Figure 3.3: Stereo microscope images of composite rod section of working insulator (SRI-3) with different magnification

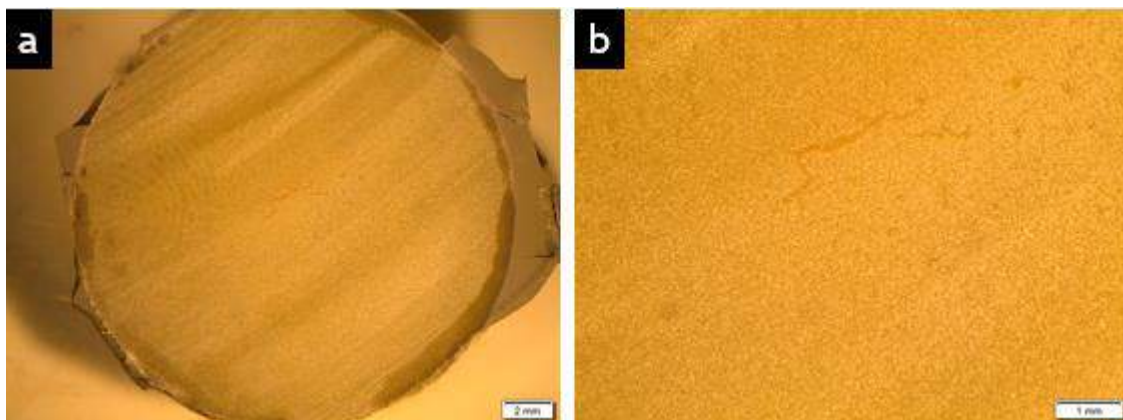
Figure 3.4: Stereo microscope images of composite rod section removed where a puncture on silicone rubber sheath was found for working insulator (SRI-4). Images with different magnifications

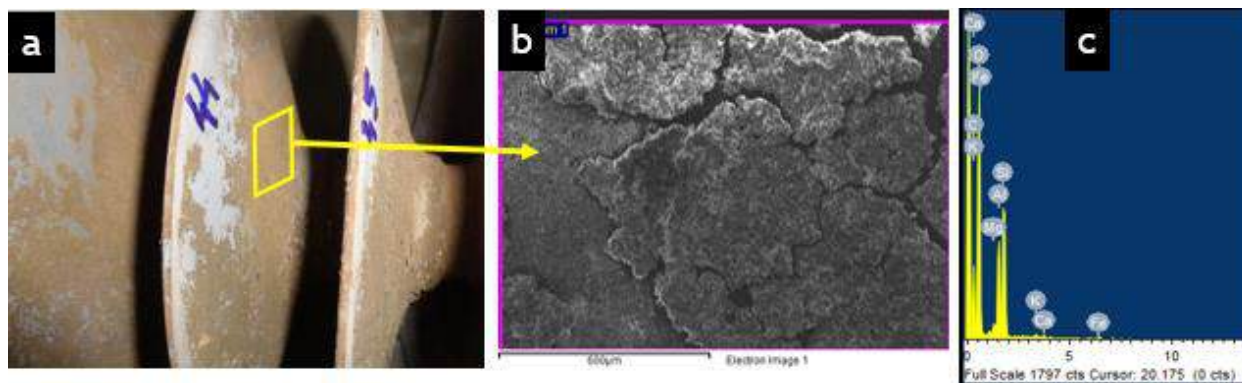
EDS is a chemical characterization technique and gives elemental composition of a material under investigation. EDS was used to analyze type of dust/pollutant particles present on the silicone rubber shades. Figure 4.1a shows a photograph of working insulator covered with dirt layer, the yellow highlighted section was used for EDS analysis. Figure 4.1b shows SEM image of area from which EDS spectra in Figure 4.1c was obtained.

Table 4.1 shows the SEM-EDS result of the silicone shade sample. Among the compounds found Carbon (C), Silicone (Si), Oxygen (O) and Aluminium (Al) are expected to found as they are all part of the silicone rubber compound. Other elements found in minor quantities such as Ca, K, and Mg can be part of fillers used in silicone compound. Carbon compound indicate that the layer on the silicone rubber is made up of organic material, which can be algae.

Figure 4.1 a) Photograph showing working insulator shade covered with dirt (Yellow Square) used for EDS analysis, b) high magnification SEM image of sample and c) EDS spectra

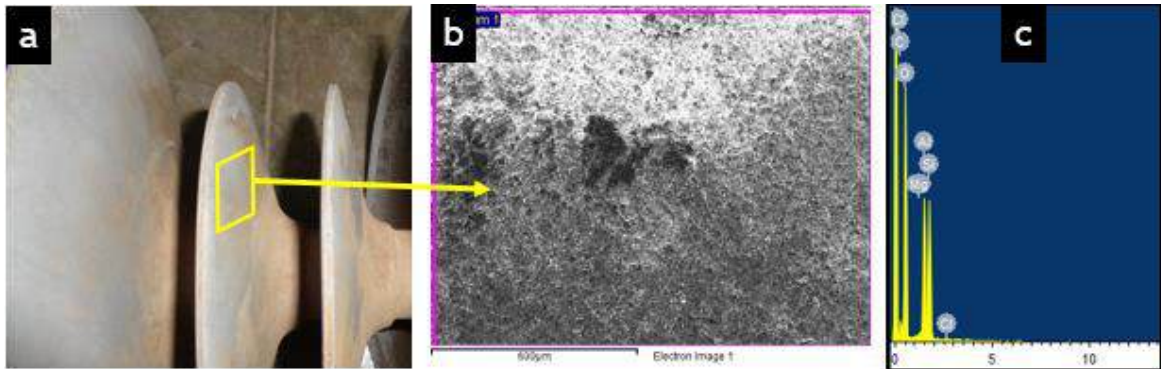
Figure 4.2a shows the silicone rubber shade without the dirt layer. SEM image and EDS spectra for the grey colored area is shown in Figure 4.2b and 4.2c, respectively. SEM-EDS result from the grey area of silicone rubber shade is shown in Table 4.2. Similar result as in Table 4.1 is observed but with reduced carbon amount. This indicate that the extra carbon percentage in dirt layer is from organic matter.

Figure 4.2 a) Photograph showing failed insulator with location of silicone rubber piece taken out for EDS analysis, b) high magnification SEM image of sample and c) EDS spectra

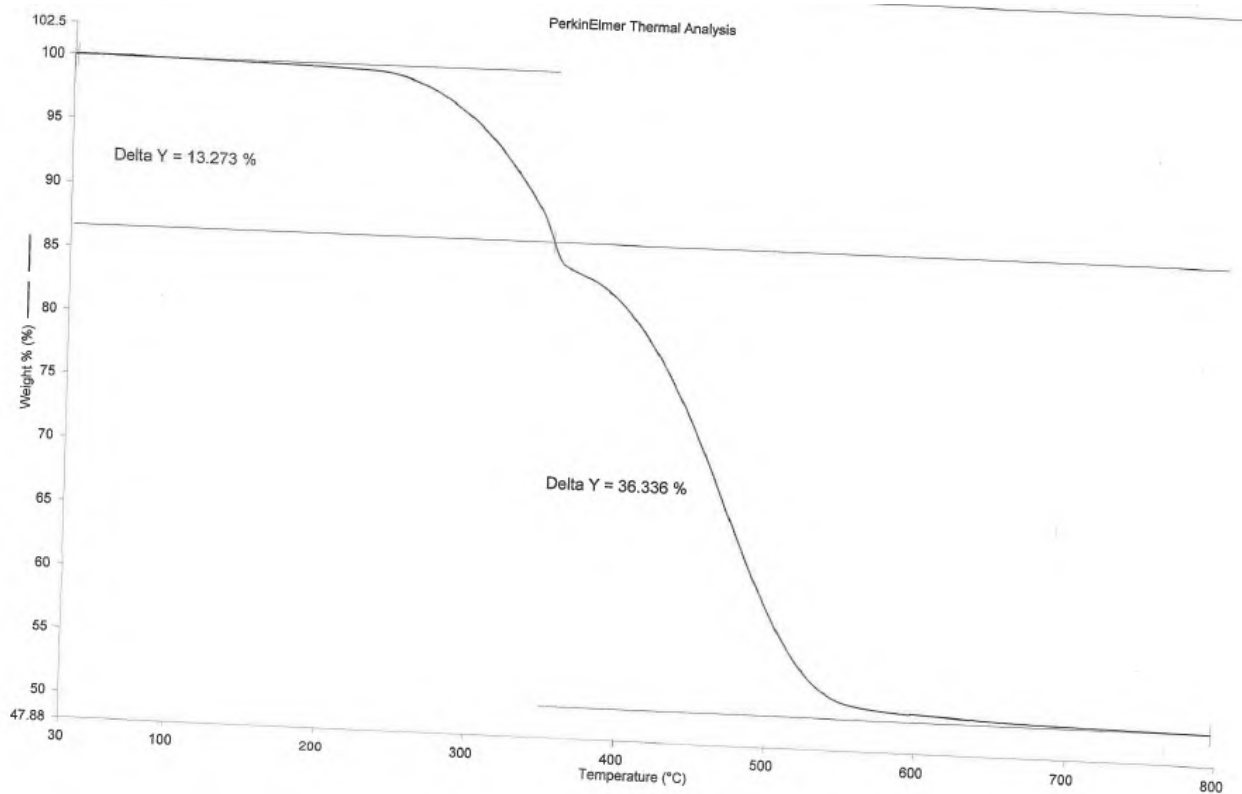
TGA is thermal analysis method in which a material is heated to high temperature with uniform heating rate while continuously monitoring the weight of material. Any change in mass of material is related to degradation or thermal stability of the material. In case of silicone rubber, TGA was used for estimation of silicone, filler and volatile matter content in the silicone rubber housing of insulator. Figure 4.3 shows TGA curve for sample from silicone rubber sample from failed insulator.

Figure 4.3: TGA graph of silicone rubber sample from failed insulator line end

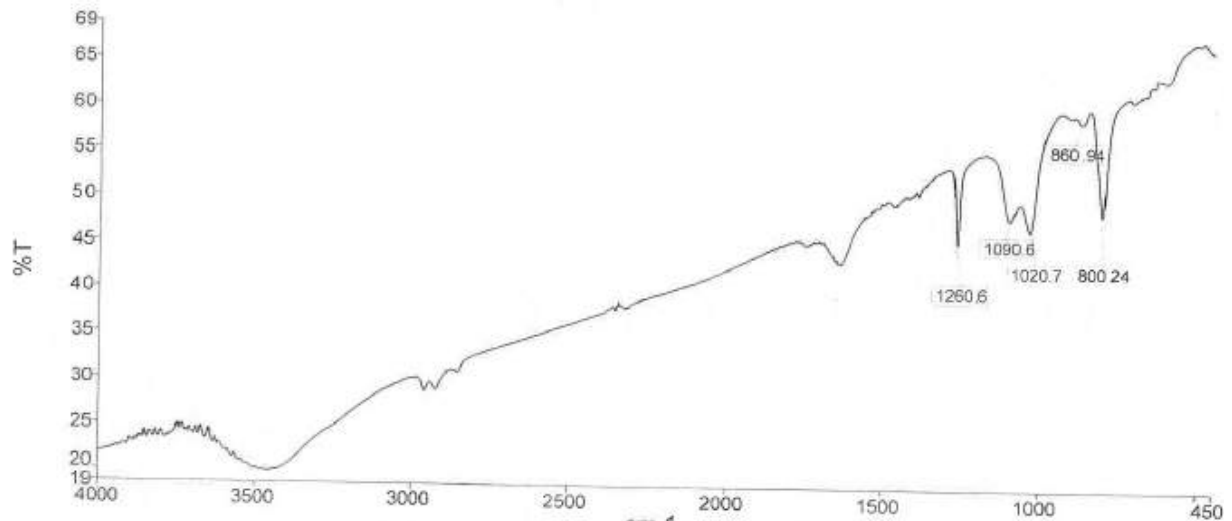
FTIR was utilized to identify the type of molecular units present in material. FTIR spectra of undamaged silicone from failed insulator is shown in Figure 4.4. FTIR identified the material as Poly(dimethyl siloxane) which is a standard silicone base used in silicone rubber compounds for insulators.

Figure 4.4: FTIR spectra of silicone rubber from failed insulator

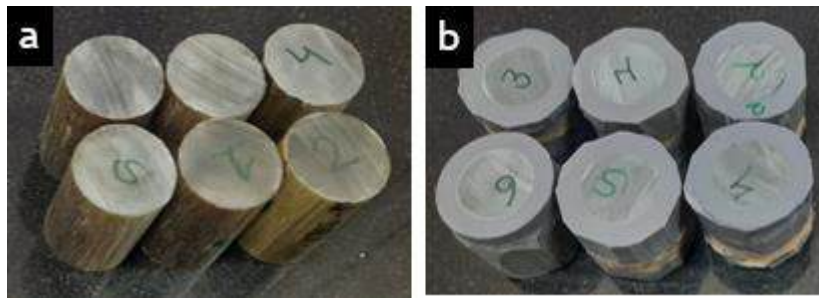
than 1 mA indicates that the sample is failed. For water diffusion test sample from failed and working insulator was tested. Specimen prepared for water diffusion is shown in Figure 4.5. Water diffusion results are shown in Table 4.8. As expected the samples for failed insulator failed the test as the composite rod was already degraded due to internal tracking. The working insulator passed the test with low leakage current value indicating good interface with silicone rubber.

Figure 4.5: Water diffusion samples: a) failed insulator (SRI-1) and b) working insulator (SRI-3)

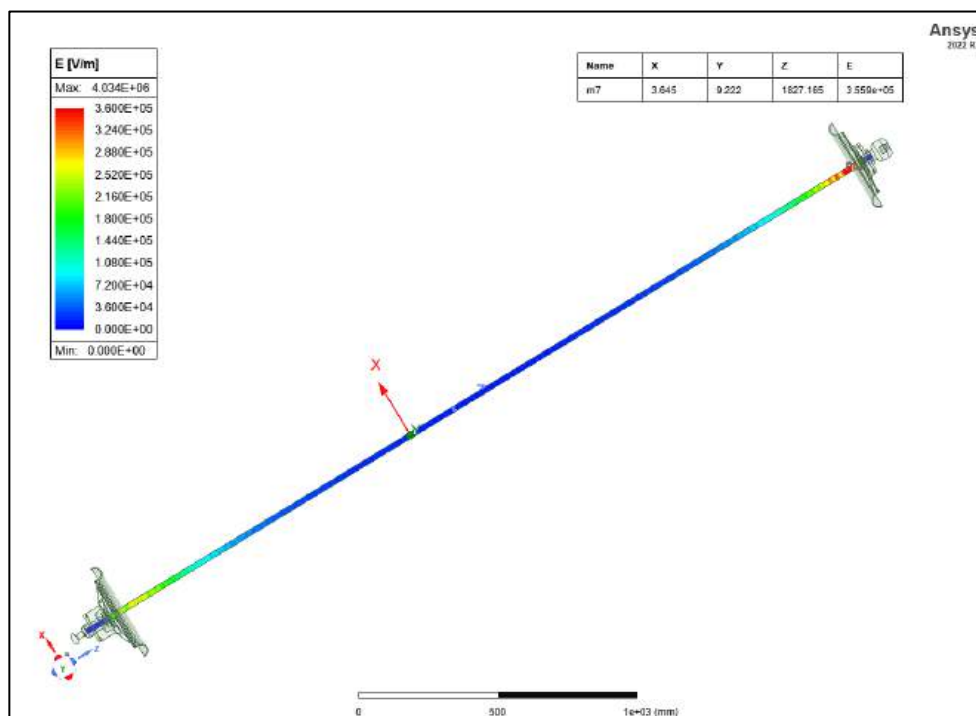
Figure 5.1 and 5.2 shows electric field distribution on bare composite rod and silicone rubber housing material. Both the figure show that the electrical stress between the tri-junction and first shade varies between 0.1 kV/mm to 0.36 kV/mm. Figure 5.3 and Figure 5.4 shows the enlarged view of insulator near line end and tower end, respectively. Maximum electrical stress found on the silicone rubber housing is 0.4 kV/mm which is below the recommended electric stress value 0.45 kV/mm (Ref. A.J. Phillip et al. IEEE Transaction on Power Delivery, vol. 23, no. 2, April 2008).

Figure 5.1: E-field distribution on composite rod surface

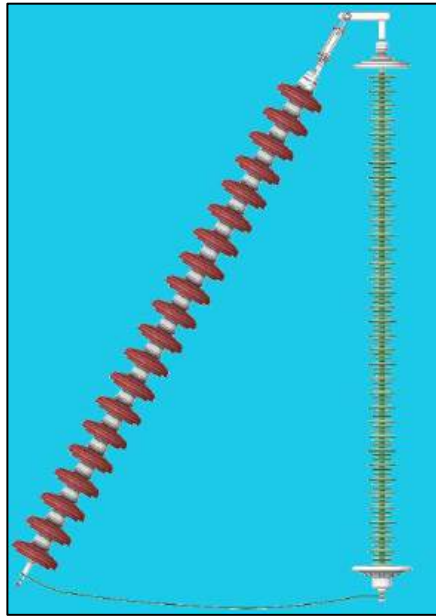
Figure 5.5: 3D model prepared for evaluating E-field on composite insulators due to proximity to the porcelain insulators

As discussed in section 2.8, the composite insulator on one side of tower 151 is in close proximity with porcelain insulator assembly. This may result in additional E-field on the composite insulator. Based on the available information and porcelain insulator drawings, 3D model of composite insulator and porcelain insulator assembly was prepared in the FEM software as shown in Figure 5.5. Due to limitations of available information, the 3D insulator assembly is not an exact replica of insulator configuration present on the tower 151. However, the 3D assembly gives a rough estimation of electrical stress on composite insulator due to its surroundings.

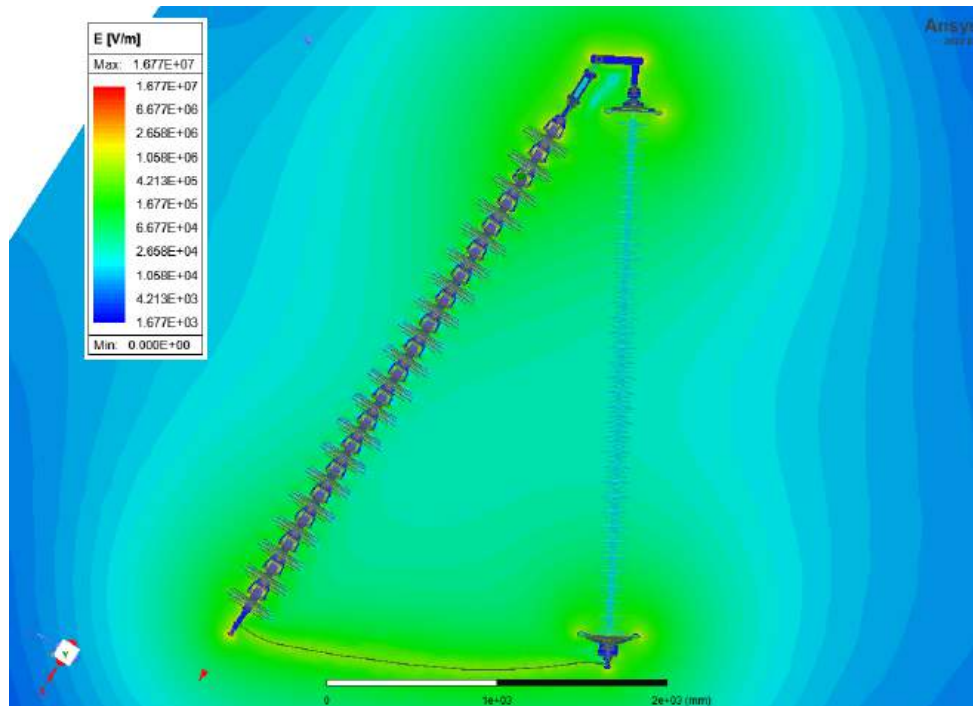
Figure 5.6: E-field distribution on assembly of porcelain and composite insulator.

Figure 5.6 shows the E-field distribution on the porcelain - composite insulator assemble simulated for  $40^\circ$  angle between porcelain and composite insulator. It shows that the, the E-field on composite insulator surface near the tri-junction is between 0.42 kV/mm to 1 kV/mm. This E-field is above the recommended value of 0.45 kV/mm. The E-field on composite insulator can further increase due to following reasons:

1. Angle between composite insulator and porcelain insulator reduces
2. deposition of algae on insulator surface and on corona rings

- Composite insulator design found to E-field values are lower than the recommended critical stress
- Due to proximity with the porcelain insulators the E-field on composite insulator increases above the recommended critical E-field
